Payload Flight Number: 20016-09	Institution: University of Central Florida
Payload Title: Hazardous Gases for Harsh Environments LED Sensor	
Student Leader: Michael Villar (Graduate Student) Mechanical and Aerospace Engineering 4000 Central Florida Blvd Orlando, Florida, 32816 mvillar@knights.ucf.edu Cell: (561) 512-3953	Faculty Advisor: Dr. Subith Vasu Mechanical and Aerospace Engineering 4000 Central Florida Blvd Orlando, Florida, 32816 subith@ucf.edu Office: (407) 823-3468
Current Team Members: Akshita Parupalli (Undergraduate Student) Mechanical and Aerospace Engineering 4000 Central Florida Blvd Orlando, Florida, 32816 Akshita.parupalli@knights.ucf.edu Cell: (321) 696-9969 Past Team Members: <div style="display: flex; justify-content: space-between;"> <div style="width: 45%;"> Kyle Thurmond (Graduate Student) Mechanical and Aerospace Engineering 4000 Central Florida Blvd Orlando, Florida, 32816 kthurmond@knights.ucf.edu Cell: (407) 617-0475 </div> <div style="width: 45%;"> Justin Urso (Graduate Student) Mechanical and Aerospace Engineering 4000 Central Florida Blvd Orlando, Florida, 32816 Justin.urso13@knights.ucf.edu Cell: (352) 817-9212 </div> </div>

Report Month: October	R

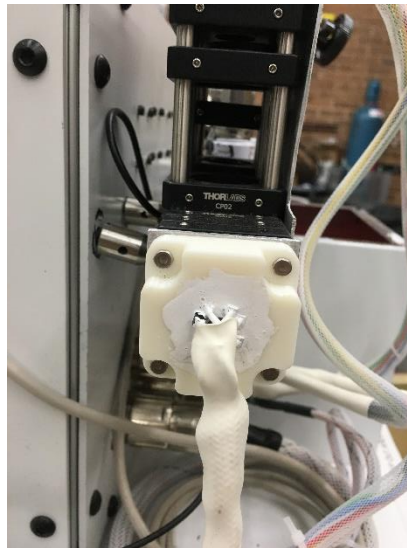
Picture showing how the optical rail screws broke off from the box

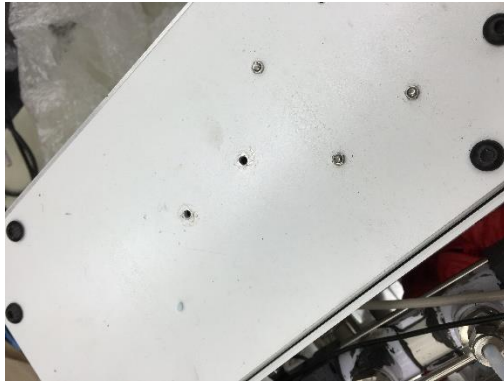
Several screws came loose, either from the force of landing or from transportation
