**Final Report for the
StratoPigeon Data Storage and Delivery Capsule Experiment
Flown on the High Altitude Student Platform 2010 Balloon Flight
August 2011**

**Connie Ciarleglio
David Thoerig
Kristy Weber
Chris Carlsen**

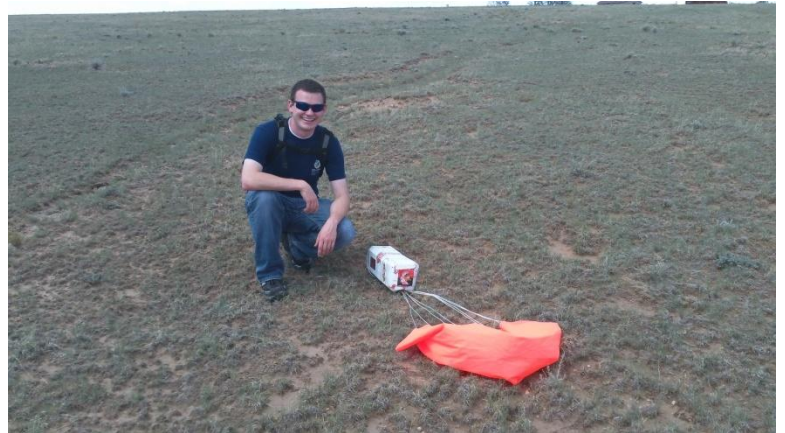
Due to protrusion of the antennas from the bottom of the payload, a crush pad system was implemented to prevent antenna damage on landing. The chosen material was a simple cardboard honeycomb structure which covered the entire length of both rubber duck antennas. The structure added minimal mass and worked well for antenna protection. On examination of the payload at the landing site, the crush pad had a single minor dent in one corner but was otherwise intact.

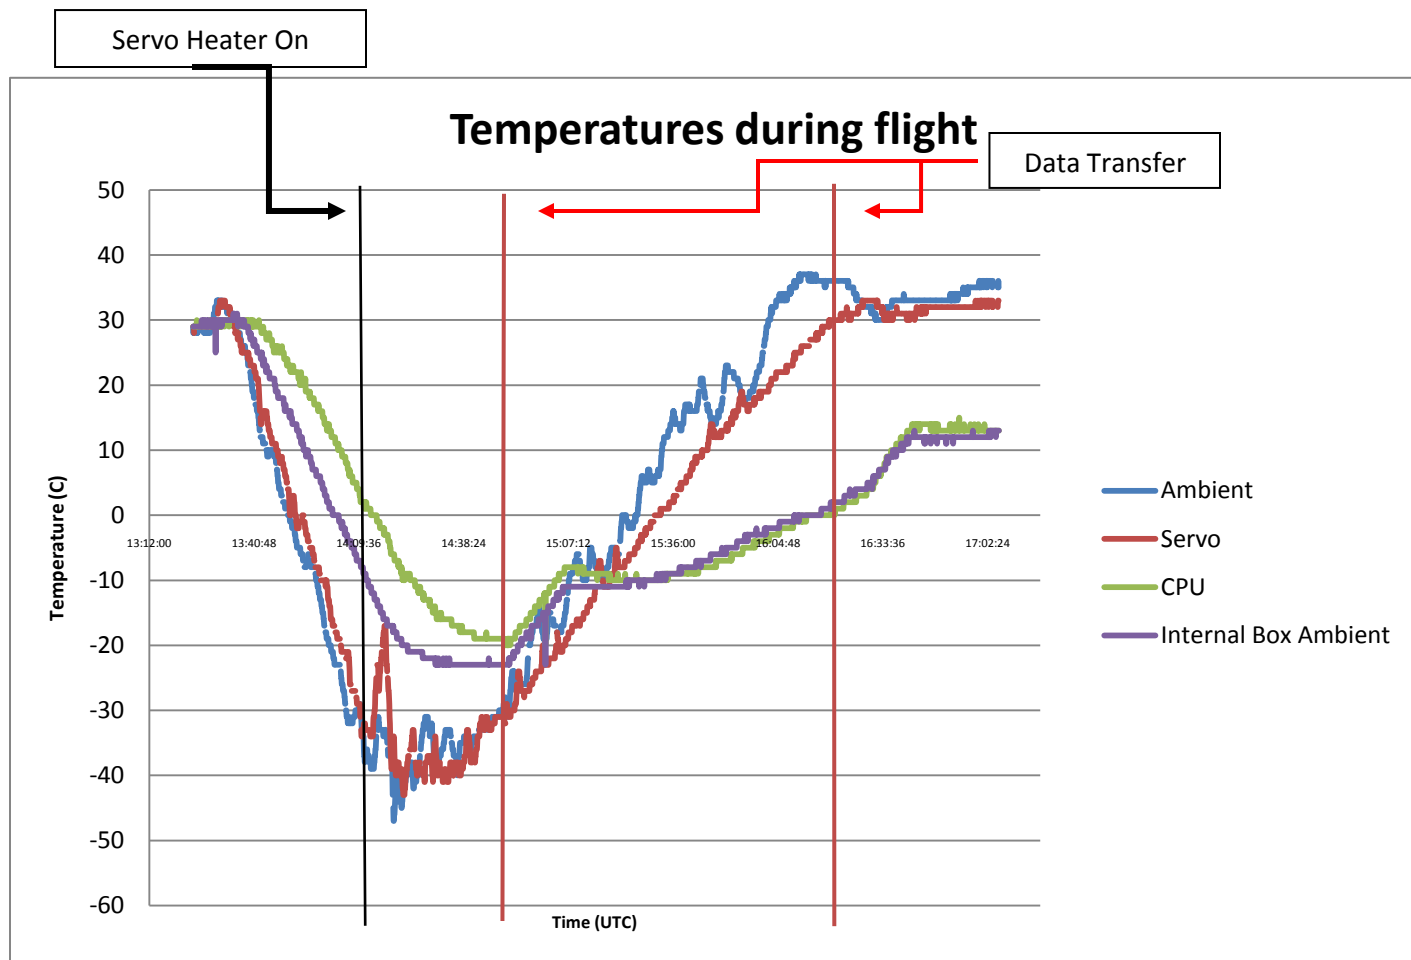
Thermal data was collected during the flight and is shown in the following graph:

Sensor	Minimum (°C)	Maximum (°C)
Ambient	-47	37
Servo	-43	33
CPU	-20	30
Internal Capsule Ambient	-23	31

Hot case thermal control worked very well. The maximum temperature encountered was well within commercial component temperature ratings. Cold case thermal control was only partially successful. As mentioned previously, the internal capsule heater actuation method failed and no additional power was used to keep the internal payload warm. However, when the CPU and SSDs are active, almost 15 W is generated, which is enough to keep the internal payload minimally warm. However, as seen in thermal chamber testing, CPU heat is not sufficient if the payload is held constantly at low temperatures. For commercial components inside the capsule, additional heating will be required, especially considering that the internal capsule spent the majority of the time below 0 °C.

The servo heater was very minimally successful. While turning on the heater did increase the servo temperature significantly, when the heater was shut off, the temperature

dropped rapidly. A less powerful heater that can be turned on for long periods of time, without risk of burning the servo, would be beneficial.

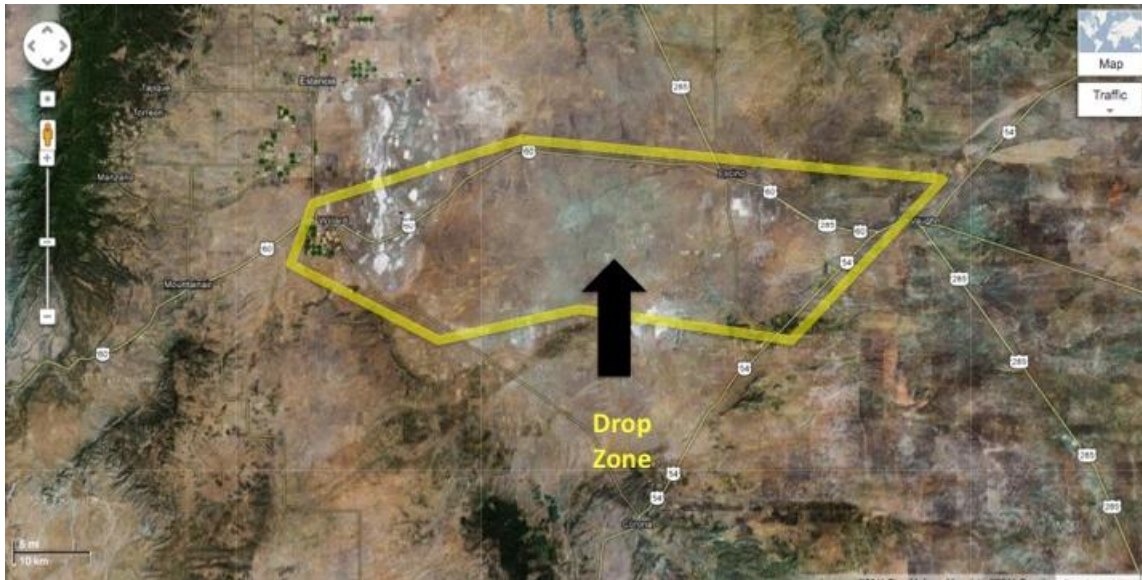
Predicted Drop Zone

Before HASP was launched, the team conferred and agreed on a "safe" region in which the drop sequence command would be given, which is the region inside the yellow shape outline in figure 1. This is a region north of Duran, North and east of Progresso and bordered by highway 42, and west of I-54. Because it was likely the actual flight path would deviate somewhat from the predicted path, the payload was planned to be released as soon as HASP got close to the 105.5th parallel.

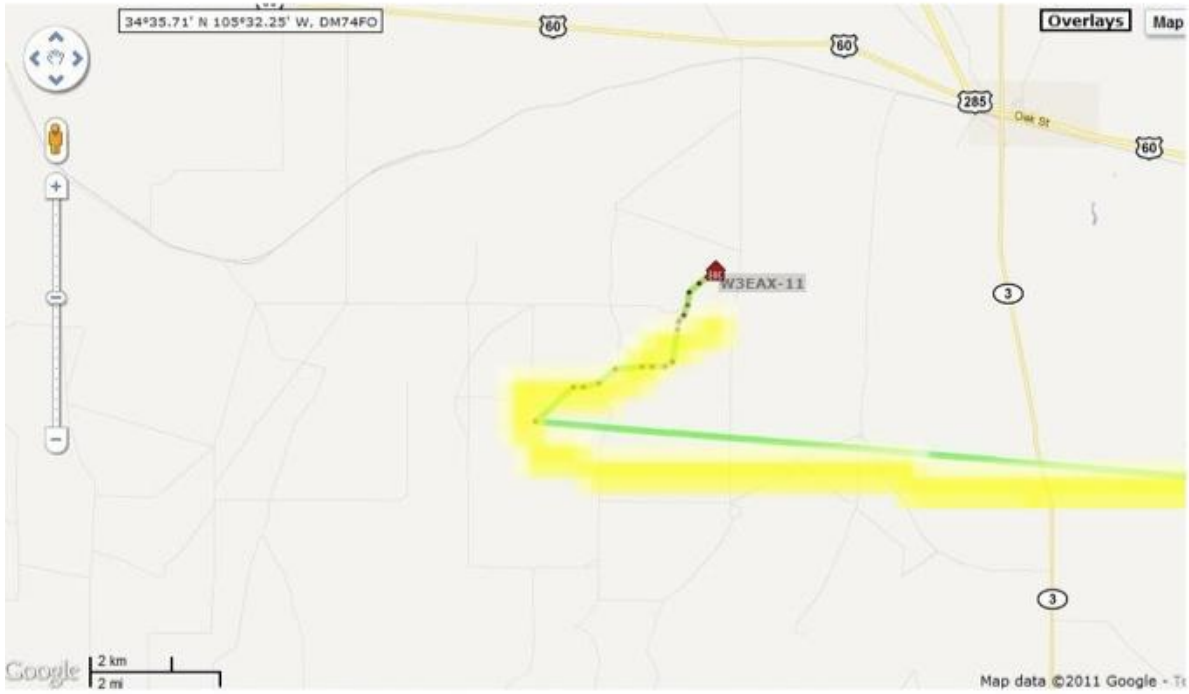
Predicted and Actual Descent Trajectory

Upon release, StratoPigeon fell along the predicted semicircular path, but with small deviations, as can be seen below. The predicted descent was traced in yellow, while the actual descent is in green. These deviations were by about 0.059° to the north, and 0.071° to the west. These deviations from the predicted path grew to about 0.072° to the north and 0.089° to the west by the time the payload landed, giving the payload an average deviation from the predicted flight path of 0.066° to the north, and 0.083° to the west. The growth of these deviations during descent can be seen in the flight path deviation graph below. This stronger deviation to the west can probably be attributed to the same strong easterly wind which caused HASP to move west much more quickly than anticipated, giving StratoPigeon the shorter than expected flight time.
