University of Colorado at Boulder HELIOS V Team September Status Report

This month was the launch of the HASP platform. During flight, HELIOS performed just as planned. It sent constant data and required commands to be sent only to put it into safe mode for a while when the Sun was out of the payload's view to save data space. Once the HELIOS payload returned to Boulder, the team got working on analyzing the data. Last week they presented their initial findings to other members at Space Grant to get more feedback on what they could learn from the collected data.

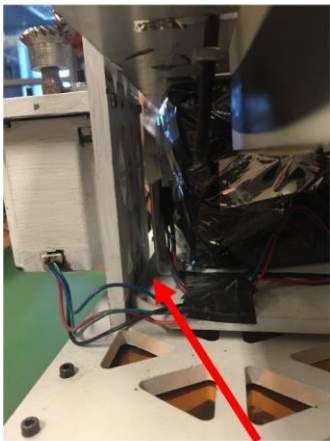
Structures: When the payload returned from flight, the structures team was the one to unbox the payload and look over it for damages. In their investigation, they found many parts of the structure damaged. The most obvious was the damage to the intermediate housing, which holds up the upper housing. The L brackets on it had been bent, and one of the bearings holding the upper housing dislodged. The damages are pictured below and the structures team has determined that they were most likely due to landing.

L-Bracket disconnected

The team has laid out a plan for the rest of the semester. This includes a final data review the week before fall break to show their completed data and receive feedback to incorporate in the final paper due to HASP. For this upcoming month, the structures team will repair the payload so that optics can use it for their failure analysis testing. Optics will be working through their failure analysis plans as systems and CDH work more on the data HELIOS collected.

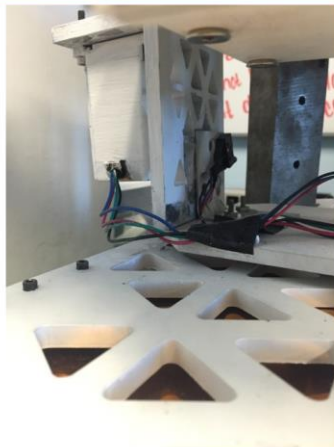
Missing L-Bracket screws

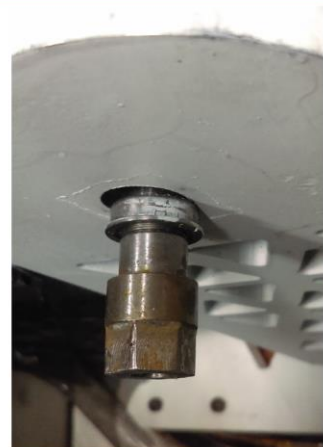
Bearing dislodged

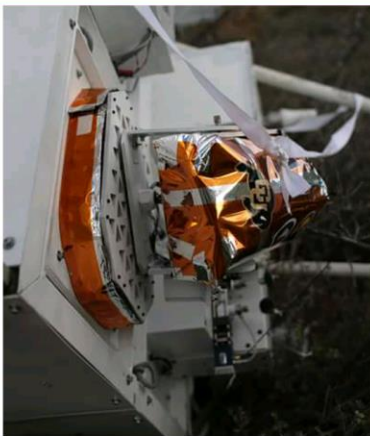
Landing Orientation

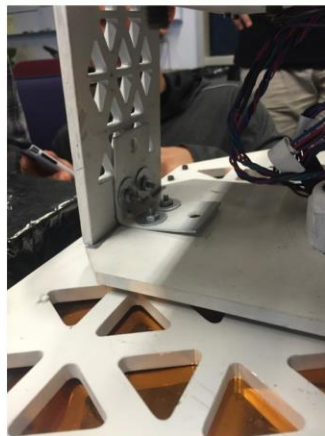
L-Bracket Bent

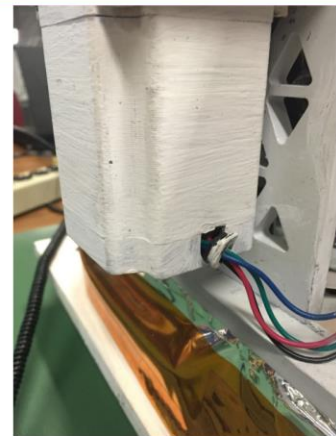
Motor wire cover dislodge

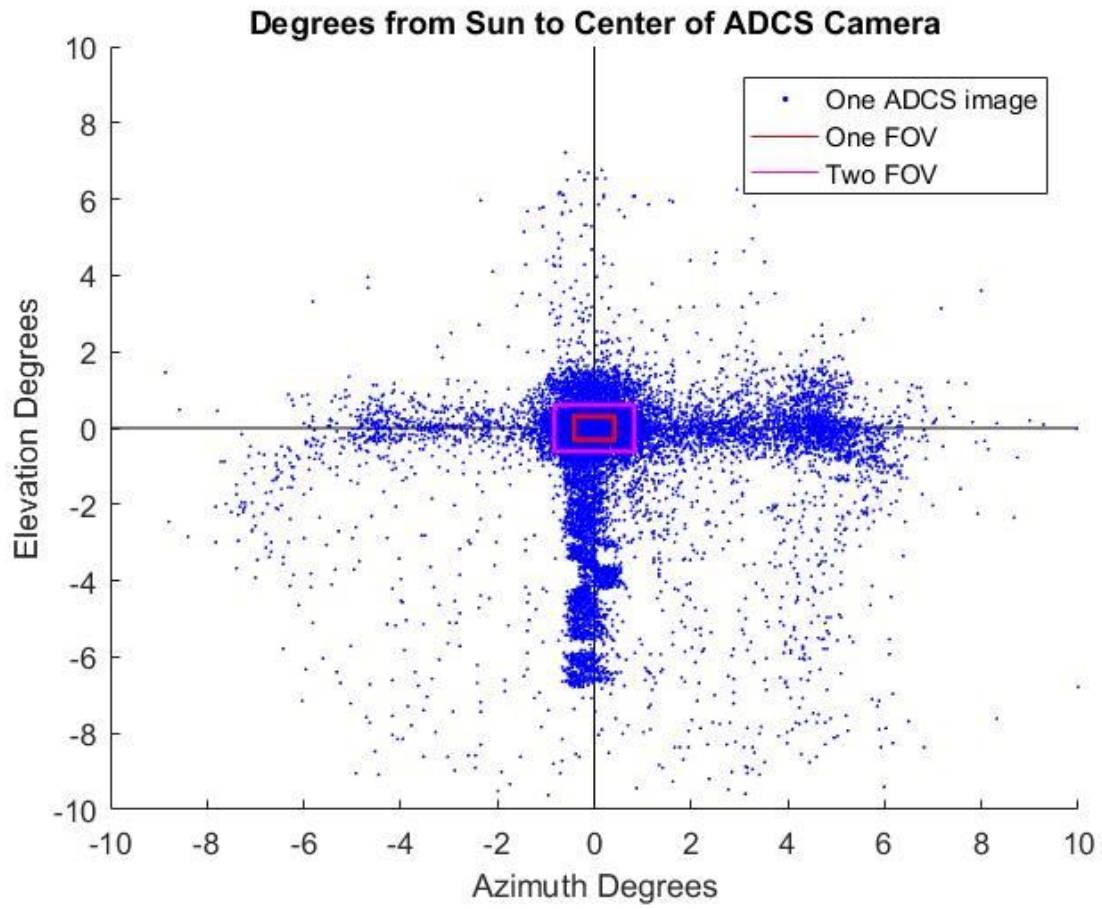
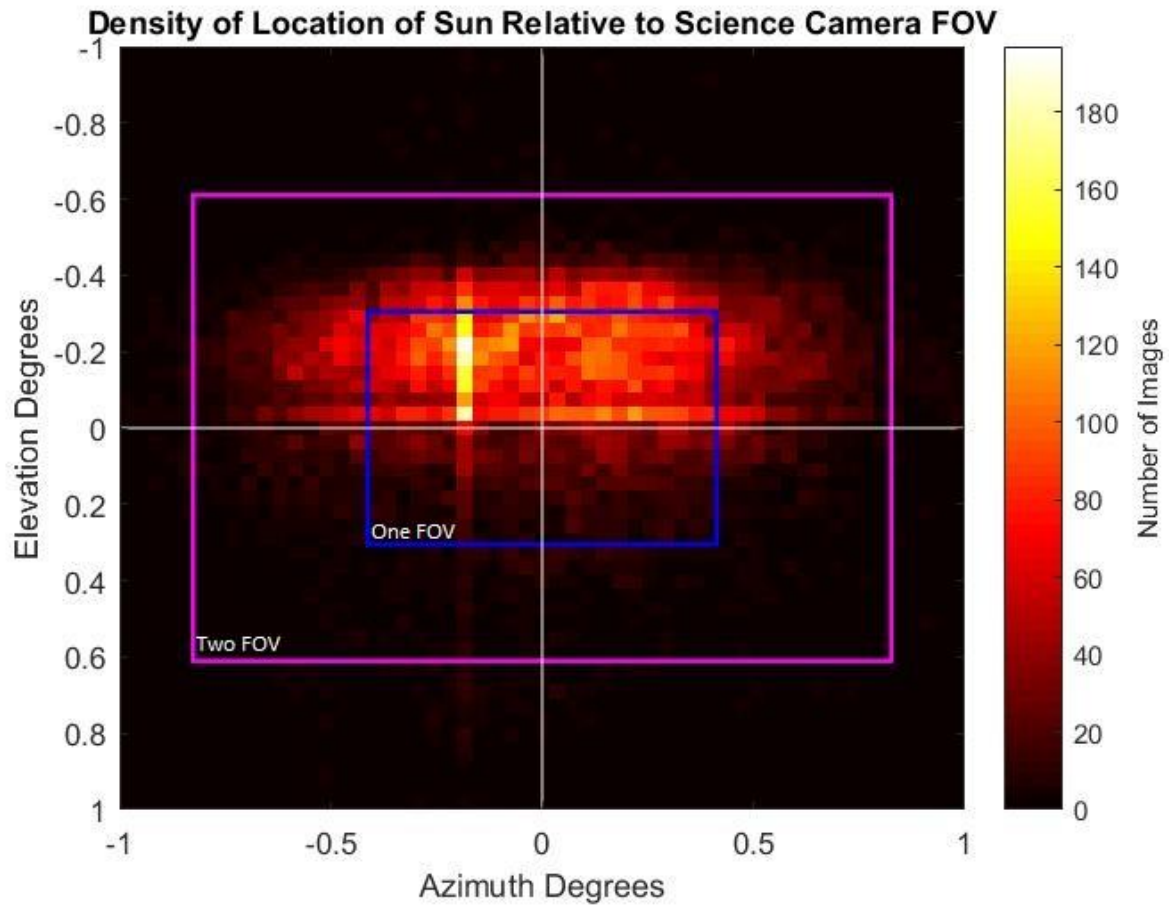
ADCS: The ADCS team also performed well during flight, though they have much more data to analyze to fully understand how well their team performed. They have created a heat map and plot, shown below, of where the Sun was located in each of the images they took, but they plan to do more with this data to fully understand how accurately the payload tracked the Sun.

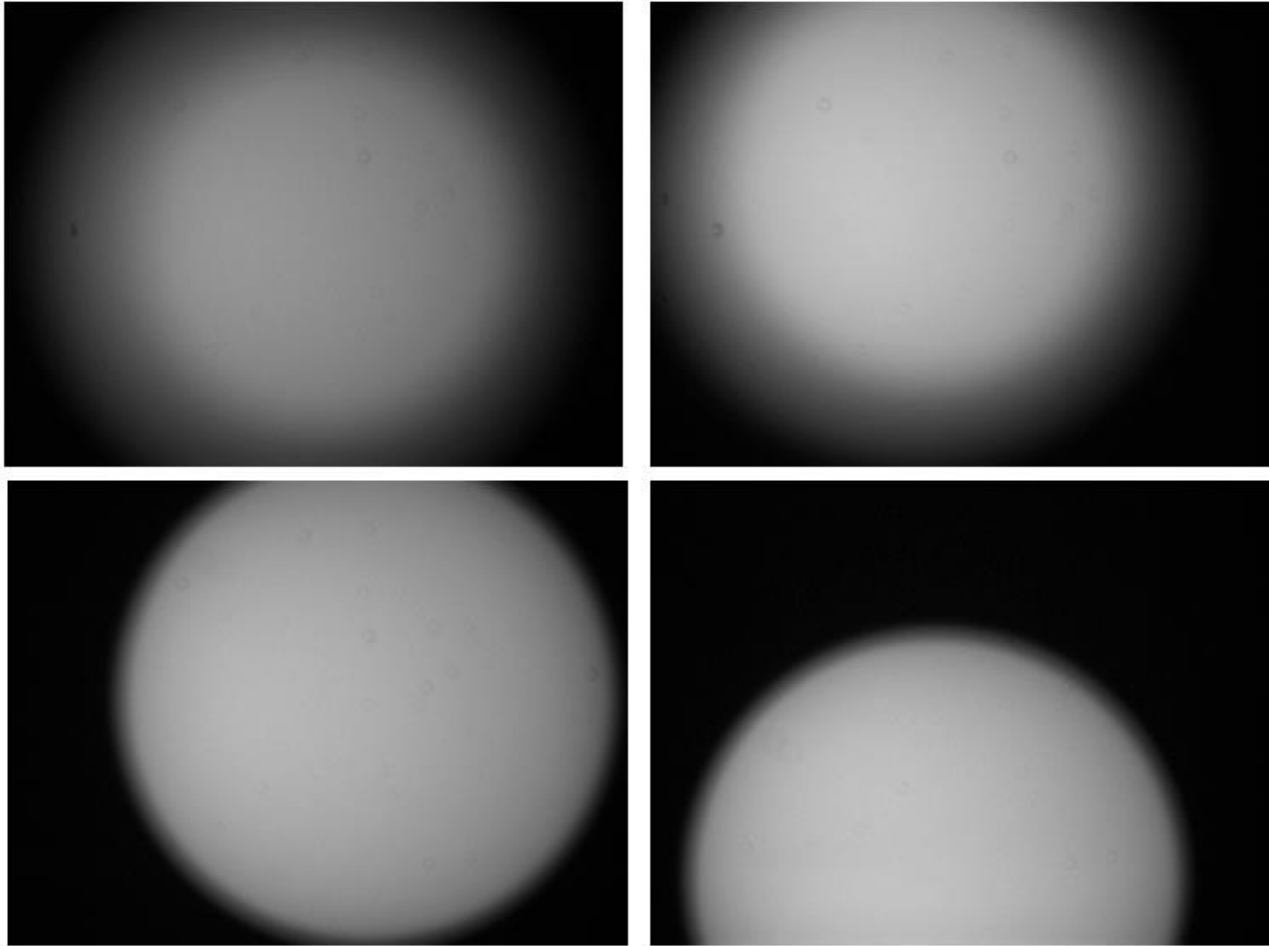
Images from flight

Optics: Unfortunately, the optics portion of the payload did not perform correctly. When payload came back and the images were opened, all of them came out variously blurred. A few samples are shown below.

The optics team has already started working on failure analysis. They have developed several theories on what could have gone wrong and have started working through them to narrow down what could or could not have happened. There were slight damages to the telescope when it returned, but nothing major enough to cause concern. The optics team's theories and plans to investigate are as shown in the table.

Theory	Plan for Testing
Incorrectly focused prior to flight	Capture images of the Sun with the current telescope configuration, which has not been touched since flight
Focus was bumped	Same as above – May be able to distinguish from above depending on how far off the focus is
Back of telescope not in usual orientation	Disassemble the telescope (will only do as the very last test)
Internal problem	Disassemble the telescope (will only do as the very last test)
Condensation	Test the effects of condensation and water droplets on images
Platform Slough/Movement	Move HELIOS around rapidly while taking pictures to see impact on images
Altitude difference	If images appear fine the ground and no other test produces the blurred images, this may be the cause

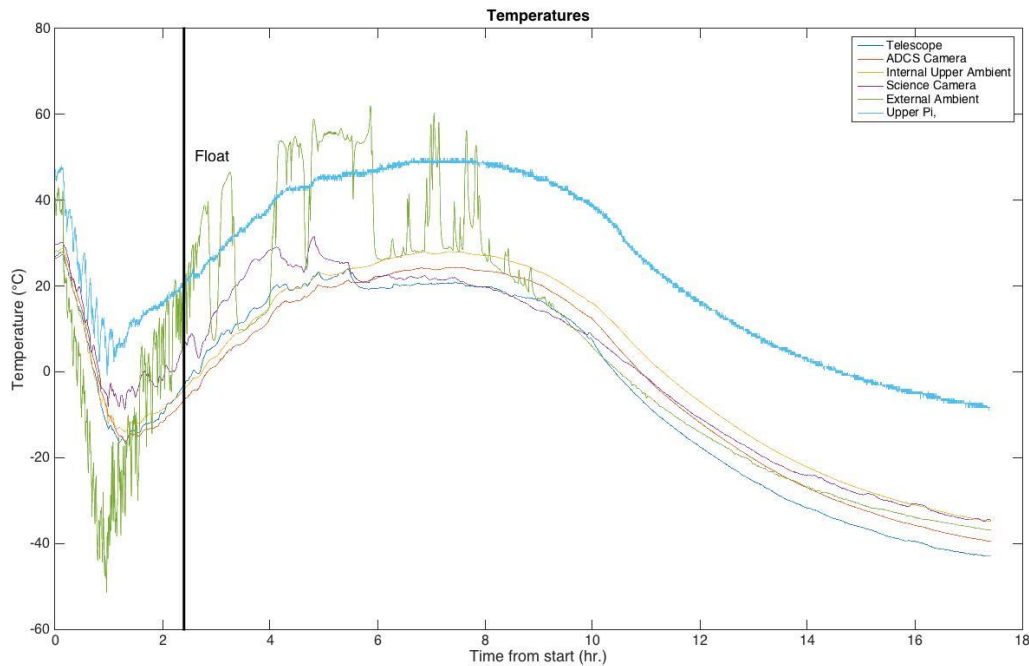
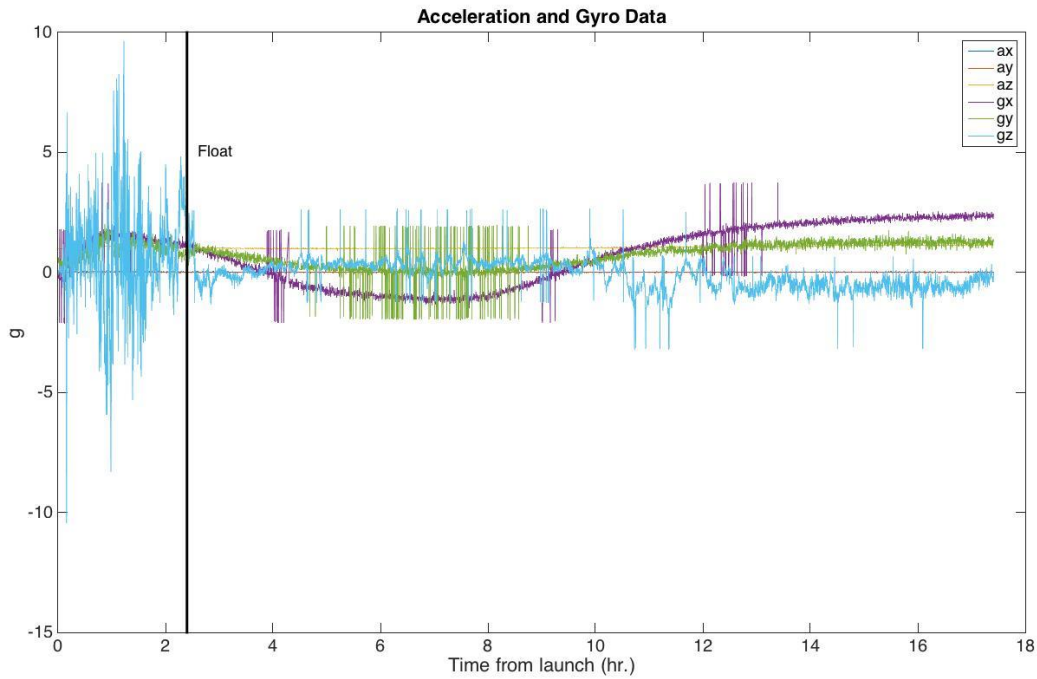
Systems: The systems team has been working hand in hand with the CDH team to analyze the data collected by the payload. They have already created the initial plots and have now begun layering them to find patterns and correlations in the data. Here are a few of their plots:
