# High Elevation Light Intensity Observation System V

## Final Science Report

University of Colorado at Boulder  
Colorado Space Grant Consortium  
Faculty Advisor: Brian Sanders

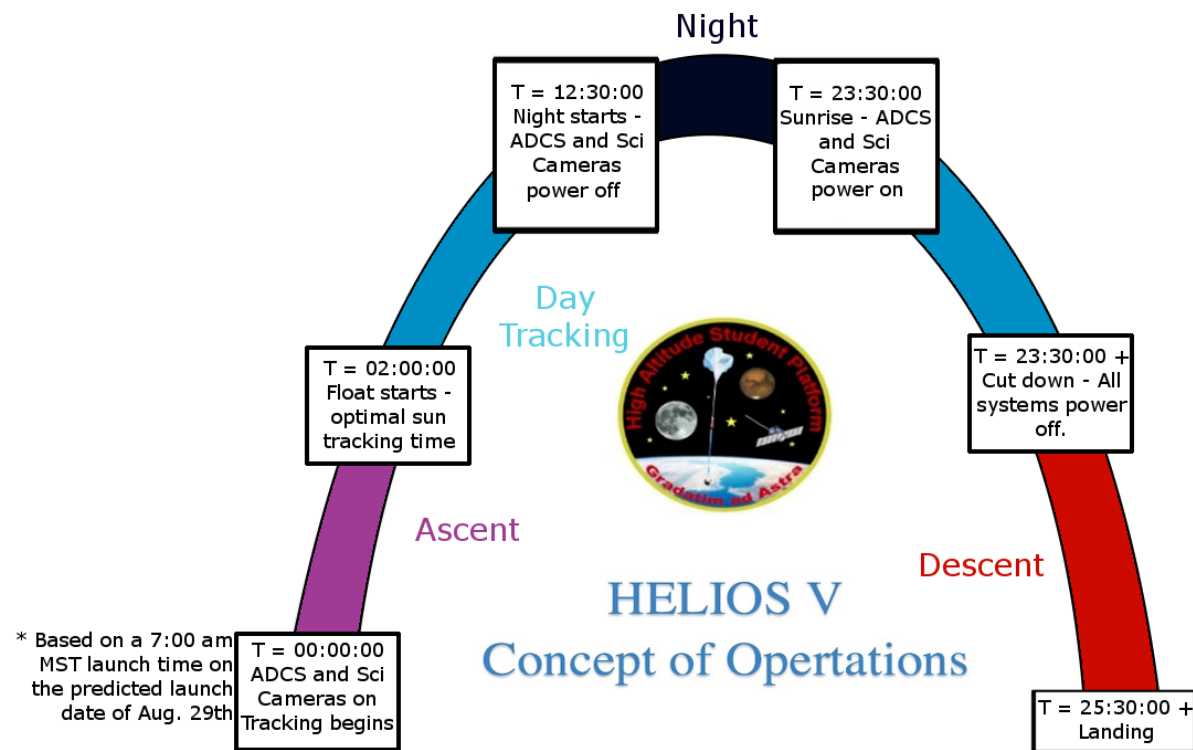
Figure 2: Concept of Operations

The Concept of Operations (CONOPS) for the HELIOS V mission is depicted in Fig. 2. This CONOPS was based off of the initial predicted flight date of August 29<sup>th</sup> with a 7:00 AM launch time. The payload would be turned on prior to launch in order to collect data throughout ascent and into the float time. Float would be the optimal tracking period for the payload. Once the Sun set, the two cameras and tracking of the payload would be turned off to save storage space. The payload would not be completely powered down in order to keep the motor drivers on and therefore help keep the payload warm. This would be done in case the flight lasted pasts sunrise, allowing HELIOS V to have another tracking period. By keeping the payload on, it would stop it from getting too cold to power back on in the morning.

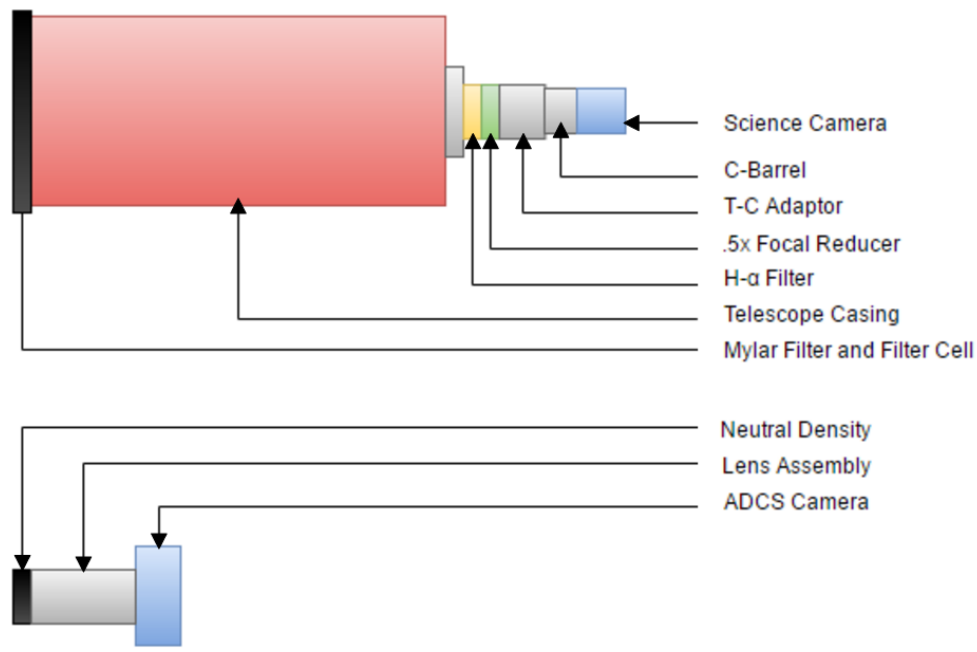
Figure 8: Optics System Overview

The primary goal for the Optics subsystem was to prove that better images of the Sun can be captured in the stratosphere than on the surface of the Earth. The overall design is based off the optical design of HELIOS III, which was the last HELIOS mission to fly an Optics system. The Optics subsystem comprises of two top-level components: the science camera and the ADCS camera. The science camera was able to capture telescopically magnified images of the Sun in the H- $\alpha$  wavelength with a small FOV for optimal image resolution. The ADCS camera was able to capture low magnified images of the Sun in the visible spectrum with a large FOV for optimal ADCS tracking.

Previous design iterations of HELIOS focused primarily on the use of a front, primary neutral density filter followed by a series of long-pass filters. These filters were used to minimize the intensity of light passing through the H- $\alpha$  filter, as well as minimizing the amount of magnified light that strikes the camera chip. Originally the HELIOS V Optics system proposed the use of a series of long-pass filters like those on past HELIOS missions. However, they were removed as it was discovered that the long-pass filters weren’t entirely necessary to protect the system, and caused measurable image distortion. Instead, the HELIOS V Optics team utilized a front primary Mylar filter that will be discussed below along with the Orion .5x focal reducer, and the H- $\alpha$  filter as shown in Fig. 8.

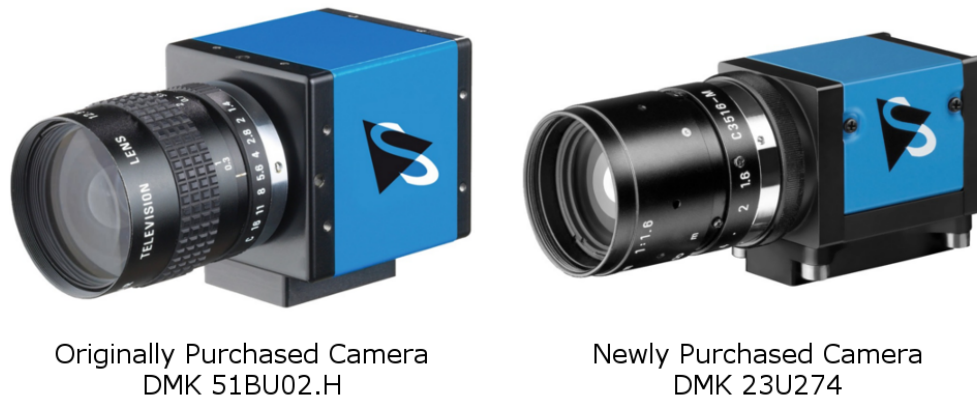
Figure 9: Camera Selection

The team began looking for a new camera, staying within Image Source since the basic code to use their cameras was already set up. When considering a new camera, the team wanted to ensure it had at least 12-bit resolution, had a charge-couple device (CCD) sensor chip, and the same or larger chip size as the DMK 51BU02.H. After extensive research into the many options, the team selected the DMK 23U274. The DMK 23U274 met all of the desired specifications, and had the bonus factor of being more compact than the DMK 51BU02.H. For these reasons, the Optics team elected to replace the old camera with the DMK 23U274, which was successfully implemented and tested.

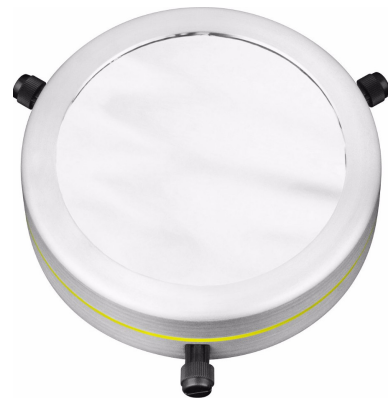
Figure 10: Orion Deluxe Safety Film Solar Filter

In addition to other filters, past HELIOS missions have used a simple and inexpensive ND-10 gel filter to filter out 99.99% of visible light. While HELIOS V Optics had originally planned on using the same material, it was eventually traded out for a Mylar filter along with a filter cell as the team had trouble taking usable images with the ND filters used in the past. While this option cost significantly more than the ND-10 filters, it was necessary in the success of the Optics team. The team purchased an Orion Deluxe Safety Film Solar Filter, shown in Fig. 10.

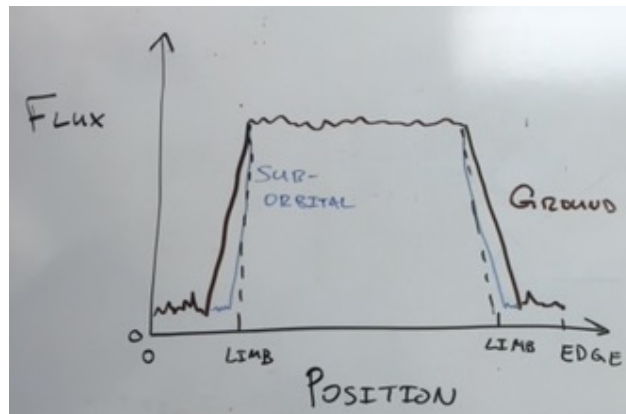
Figure 11: Pixel Plot Explanation

The image being in focus was the second part of the successful image definition. To do analyze this, the Optics team needed a method to quantify the focus of an image. Assistant Professor Jason Glenn, one of the Optics team's mentors, introduced the team to the method of pixel plots. This method plots a row of pixels from an image as a series of values from 0 to 1, 0 for black and 1 for white.

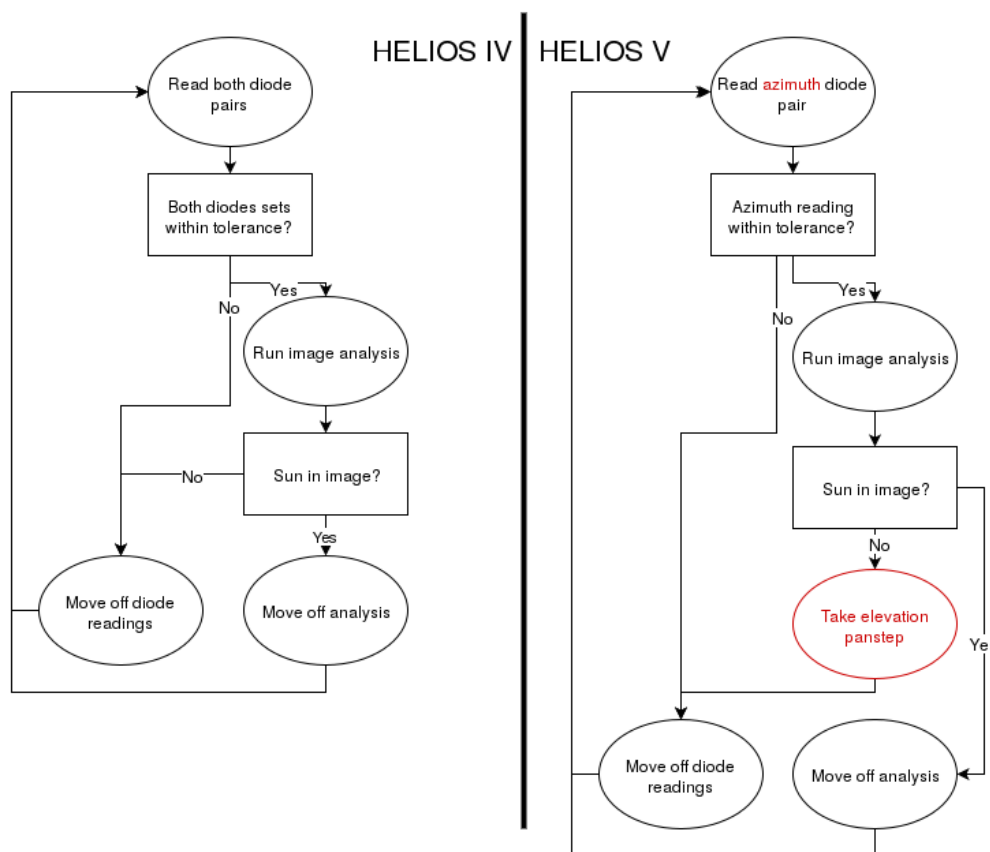
Figure 13: Sun-tracking algorithm. Changes from HELIOS IV shown in red.

HELIOS V differed from HELIOS IV in that only one pair of photodiodes were used. In the design of HELIOS IV, two sets of photodiodes were used for rough tracking on both the azimuth and elevation directions. Electrical problems with one set of photodiodes (as discussed later) necessitated a change in the tracking algorithm. The ADCS team decided to modified the tracking algorithm to use only one pair of photodiodes, as shown in fig 13.

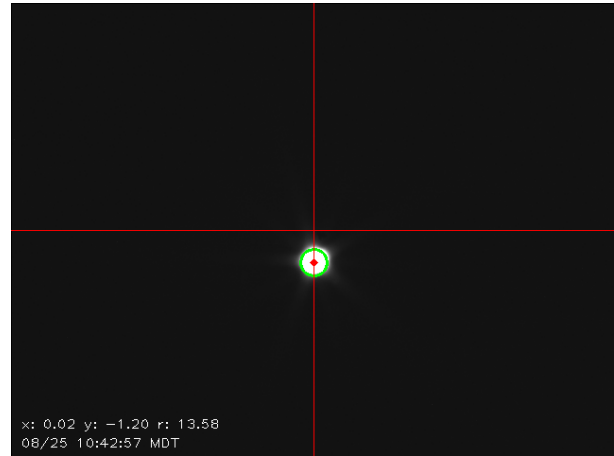
Figure 14: Fine tracking using ADCS image analysis. Distance from image center to Sun center shown in bottom left.

The ADCS thread ran all of the Sun tracking code for the mission. This included running the tracking algorithm main loop six times per second, recording status messages, and taking an image such as the one seen in Fig. 14 every ten seconds.

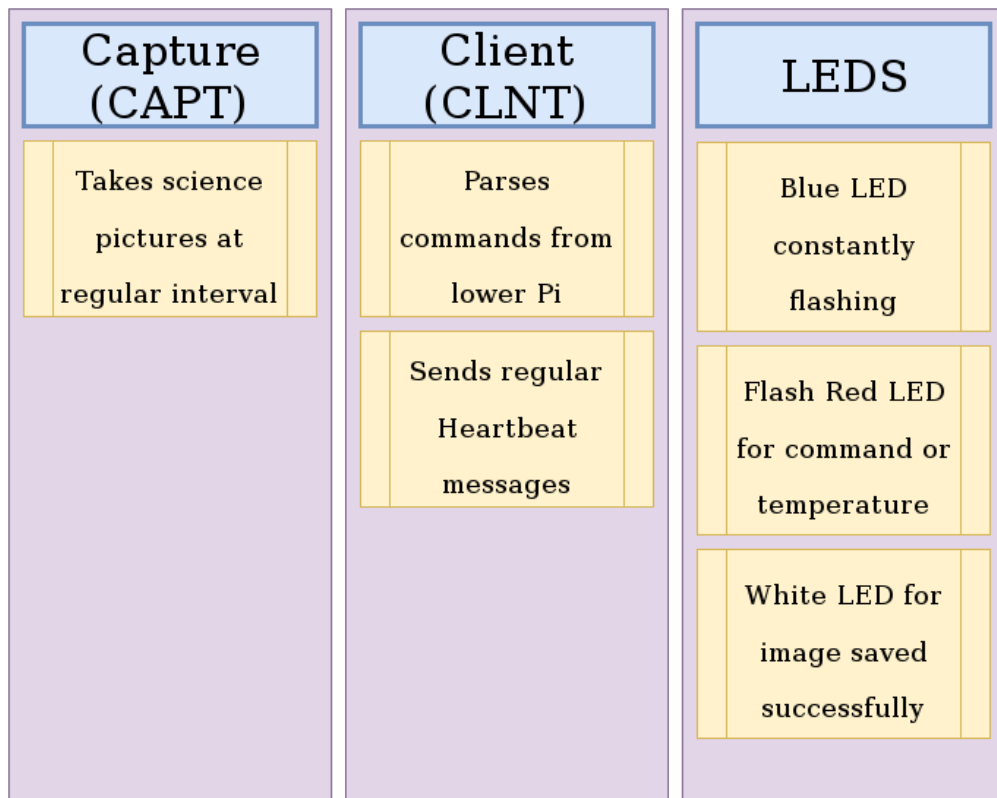
Figure 16: Python threads running on the Raspberry Pi 2 in the upper housing. All threads needed to be written for this mission, as HELIOS IV only flew one Pi.

The two Raspberry Pis maintained a Transmission Control Protocol (TCP) link over an Ethernet cable for the duration of flight. The Server thread initialized and maintained this link. The implementation of a basic communication protocol between the two Pis was inspired by the OpenSSL "Heartbeat" extension. Every 5 seconds, the Server thread sent a simple message to the Upper Raspberry Pi, including commands if any had been received from the Uplink thread. Before each of these messages, the temperature readings from the temperature sensors was checked, and a warning was sent if the value was too high.

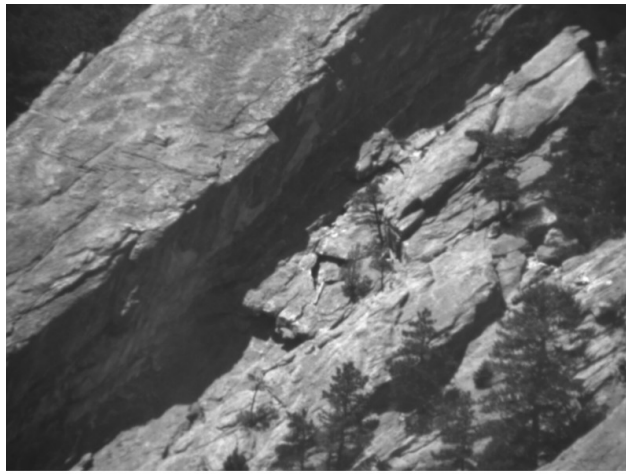
Figure 18: Images during heating

Image of the Flat Irons during first heating test

The goal of the heat test was to see how heat impacted the optics system, and in particular, the telescope. The maximum temperature to test the optics system at was chosen to be 50 degrees Celsius. The operating temperature of the camera was given by the manufacturer as 0 - 45 °C. A temperature was chosen slightly above this range to account for any possible error during flight that would cause the system to heat above this temperature range. To perform this test, a solar oven was created by forming a box without a lid using foam core. Saran wrap was used to cover the box to keep the more contained around the optics system. Four resistor heaters were placed inside the oven along the edges. Four temperature sensors connected to an Arduino were also placed inside to collect the temperature data during the test. The telescope was pointed at the Flatirons, a rock formation on the mountains next to Boulder, and images were taken to compare with the images taken during and after the heat test. The telescope was then placed into the solar oven and temperature data was recorded every 15 minutes. The telescope was taken out of the oven about once every hour, when it would then be used to take more images of the Flatirons. This process continued for four hours, and then the images taken during the test were compared to those taken before the test. The heat test was determined to be a success since there was no measurable impact on image quality by the heat.

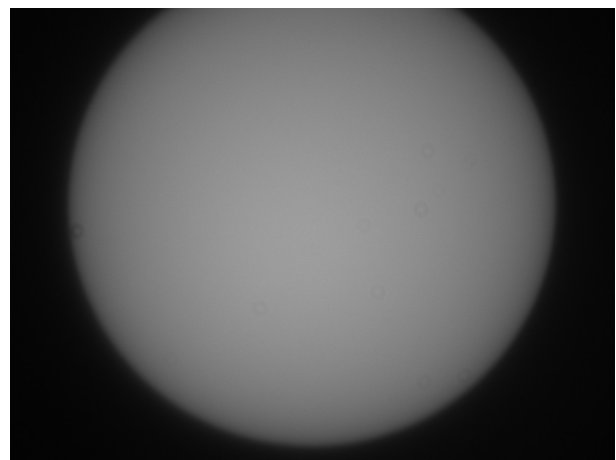
Figure 20: Image taken with field of view of .6402 x.4801

This equation was used to find an approximate initial position of the focal reducer that would optimize the FOV (around 47.5 mm with a focal length of 95 mm with the .5x focal reducer). Images were then taken with this configuration and the field of view was calculated from these images. From these calculations, it was determined whether or not the position of the focal reducer should be adjusted. This was done using a number of empty barrel attachments that would either lengthen or shorten the distance between the focal reducer and the camera chip. In addition to this, it was taken into account how easy the image was to focus and if any sort of lensing effects were present.

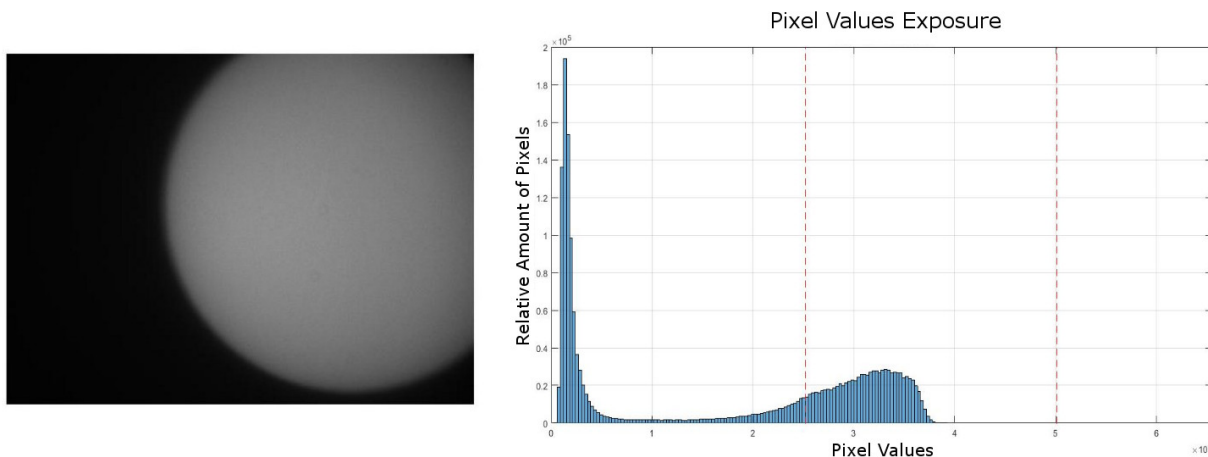
Figure 22: Successfully Exposed Sample Image and Plot

This process was repeated until the image was indistinguishable from a black background. From this point, a histogram was created of pixel values across an image. The values of pixels across an image range from 0 to  $2^{12}$ , denoting the upper dynamic range of the science camera. The goal was to take an image that had the peak of its pixel value distribution in the range of 40-70% of the maximum value, indicating that the image was not saturated, nor was it too dark to distinguish features on the Sun. This was balanced with trying to keep the signal to noise ratio at a minimum using the built in gain function on the science camera. A visual representation of the results can be seen in Fig. 21. Based on this test it was possible to conclude that an optimal exposure for the science camera would be between approximately .08 and .13 seconds. While these moderately long exposure values could possibly allow for pixel smearing as a result of platform slew, it was deemed acceptable based on accelerometer and gyroscope data from HELIOS IV and the pursuit of less noise on the images. An example of a properly exposed image from the test is shown in Fig. 22.

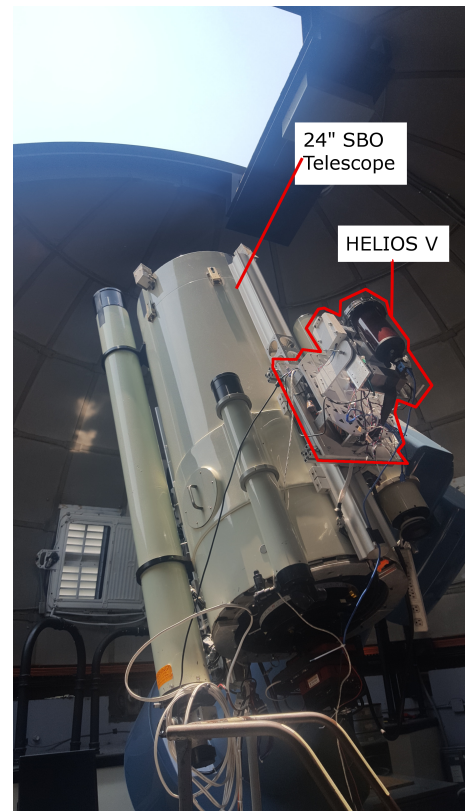
Figure 23: HELIOS V attached to the SBO telescope

Fig. 23, left. Both the science and ADCS cameras were connected to laptops to show live feeds from the cameras.

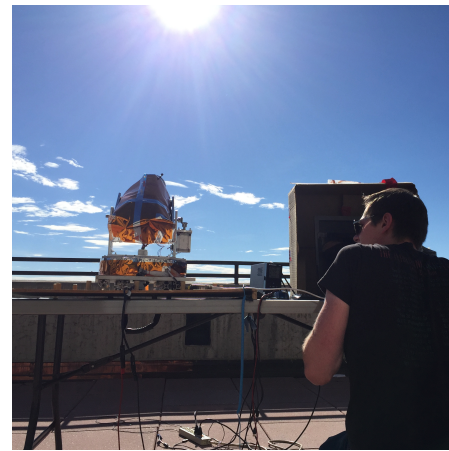
Figure 24: Set-up of system testing

Once the payload was powered on and the cameras were verified to be working, the test members would begin to rotate the payload in increments and watched how the payload reacted. This included 10°, 30°, 45°, 90°, 180° off the “zero” position facing the Sun. If the payload found the Sun in a smooth and timely manner, the team would move on to blocking the camera or photodiodes. This demonstrated the ability for the payload to react to shadows from the balloon, other payloads, or a lull in tracking. The payload was designed to continue to seek the Sun but refrain from drastic changes in position. System tests were concluded with a brief run-through of the commands, especially the nudges, once again to ensure the payload could find the Sun again.

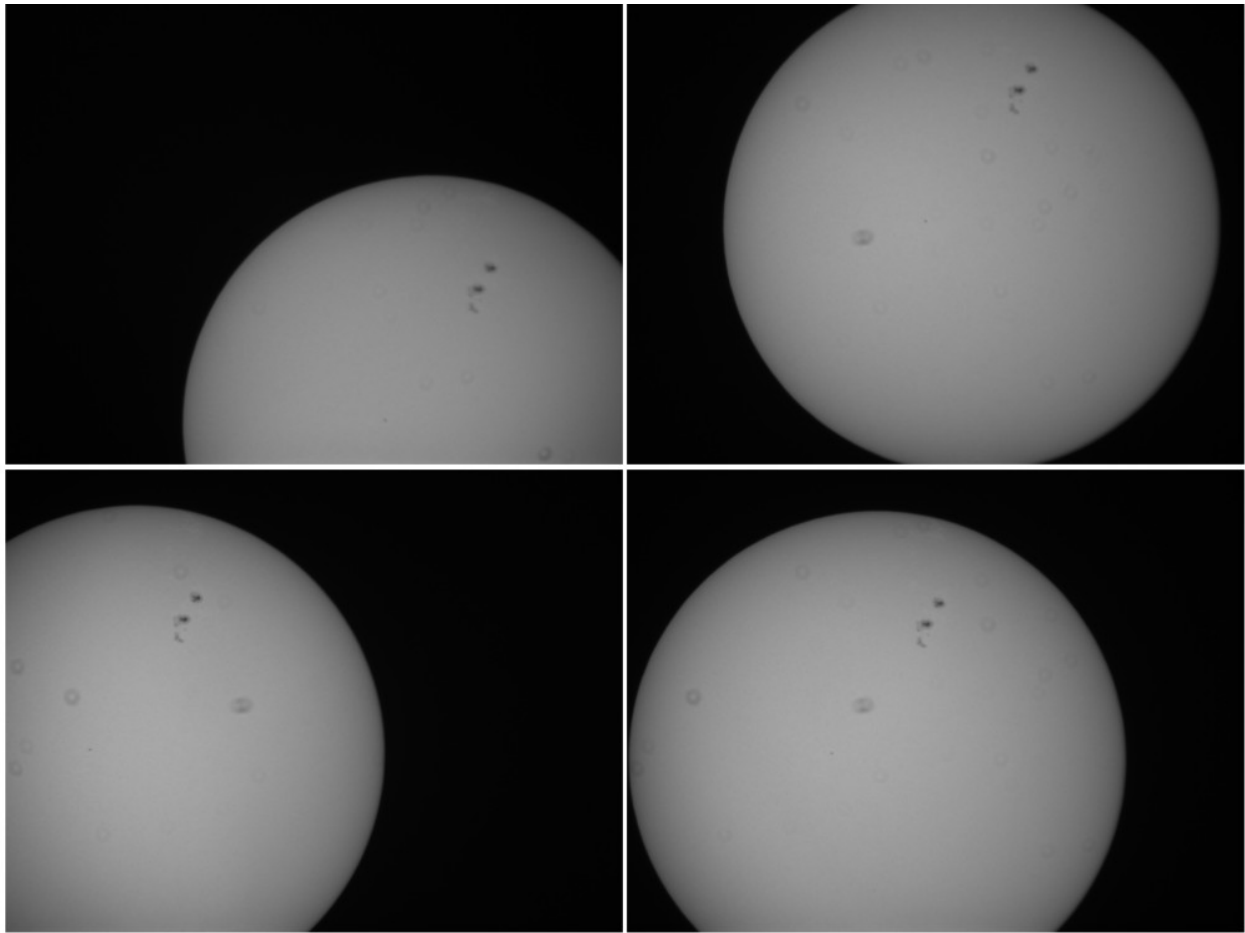
Figure 26: Sample Ground Images

Another purpose of the tests were to provide the set of ground images that would be compared against the flight images. This was to test if the image quality in the stratosphere was, in fact, better than the ground quality. Figure 26 is a few of the images taken during the second DITL test. As seen in these images, the Optics system was capable of capturing very clear Sun images with distinguishable sunspots.

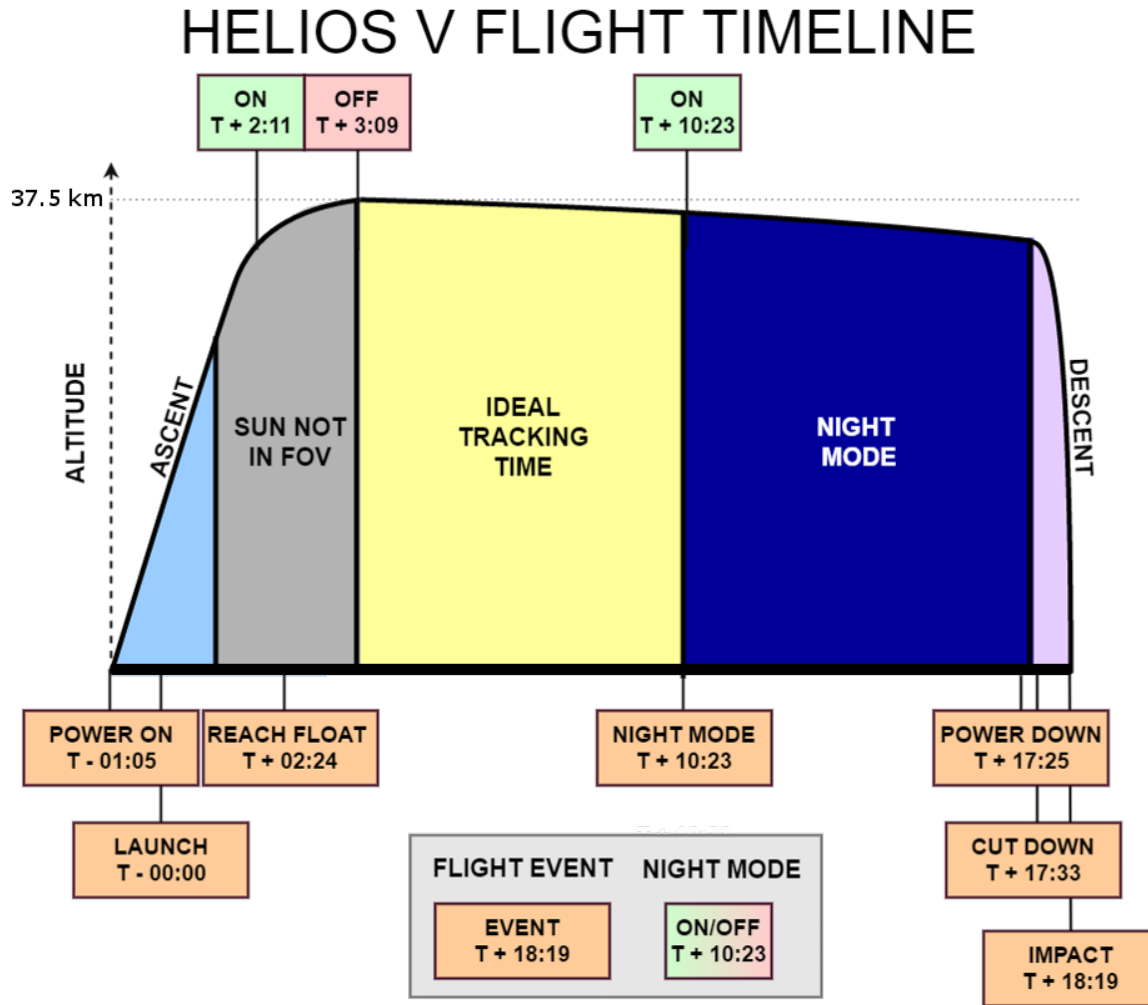
Figure 28: Flight timeline

The HASP 2016 balloon launched on September 1<sup>st</sup> at 10:08 AM MST after a weather delay that morning. From this time, the flight proceeded as pictured in the timeline of Fig. 28. The major events of flight are on the bottom of the timeline in orange, while the commands sent are above in green and red.

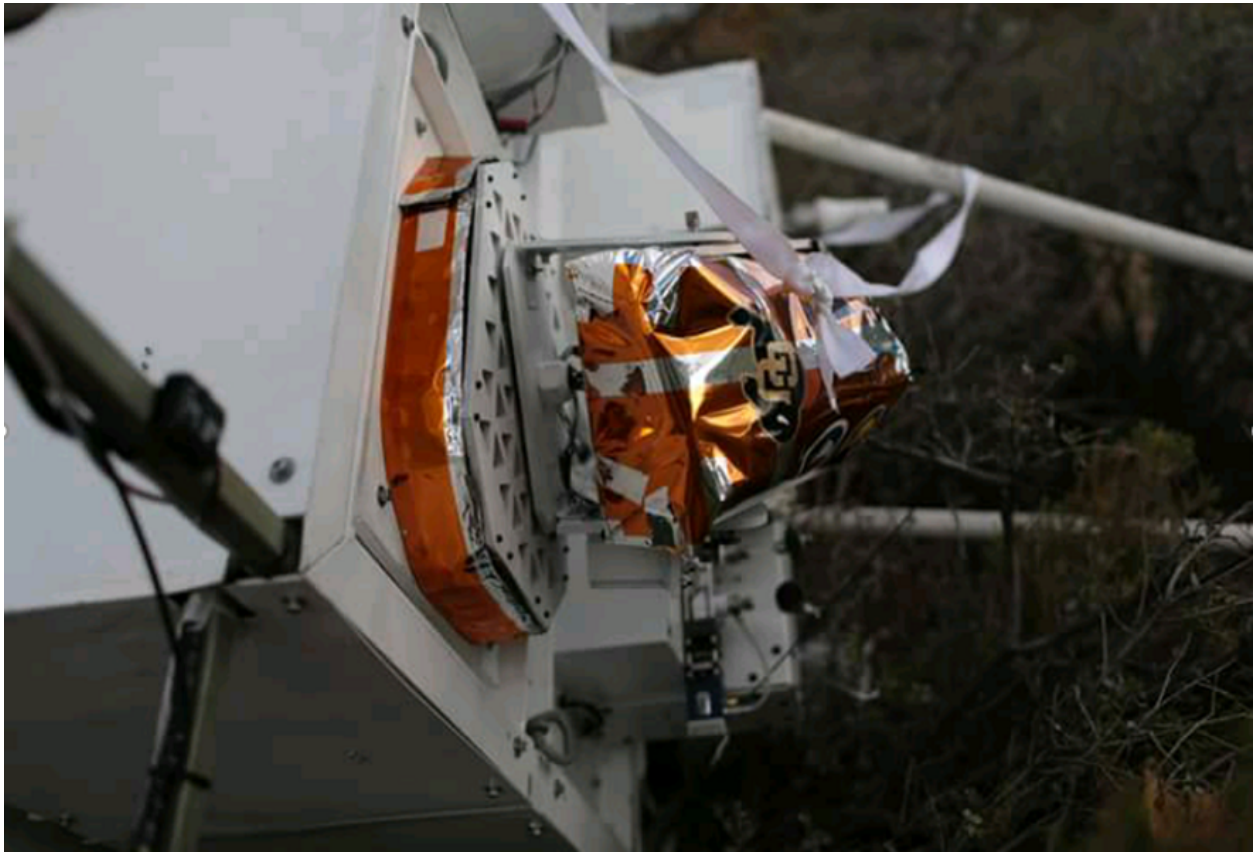
Figure 37: Landing Orientation of HELIOS on the HASP Platform

While there was no way to monitor the structure at any point after the HASP platform was cut down, all damages to the structure faced in the same direction. This can be explained by examining the orientation of the landed HASP platform as shown in Fig. 37

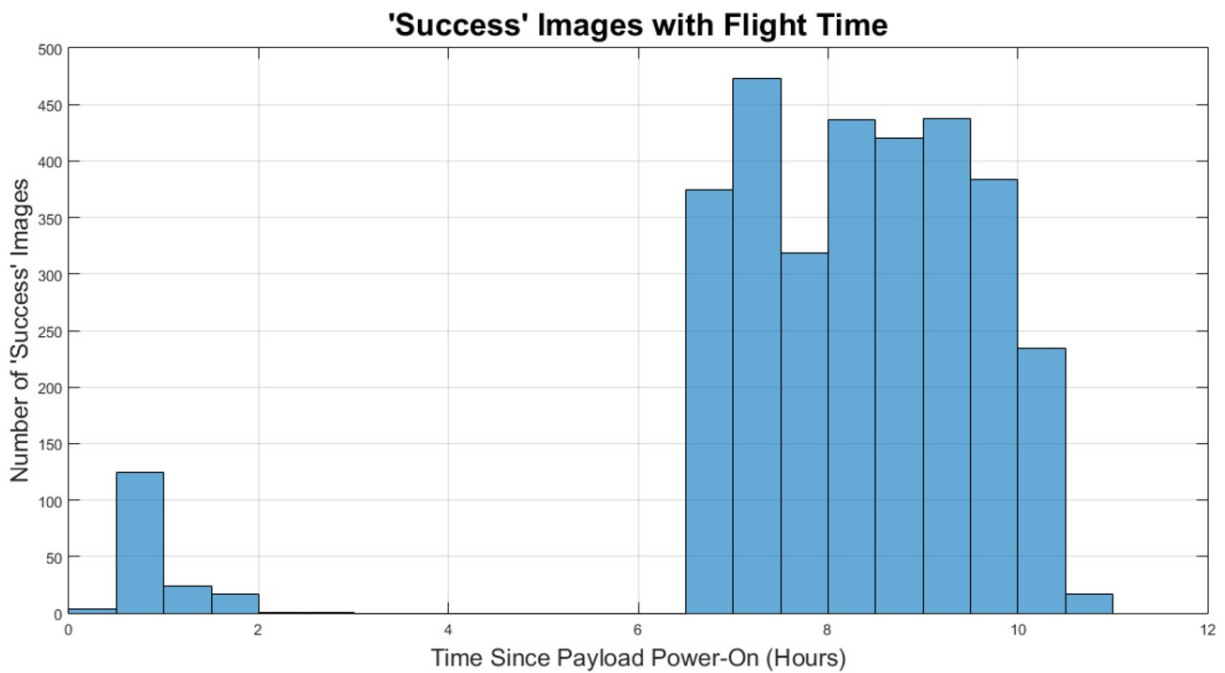
Figure 38: Optics Success Images with Flight Time

Of the science images captured, 3,268 of them were considered successful based on the Requirements' definition, meaning they contained at least 50 percent of the Sun. The number of successful optics images as a function of flight time is shown below in Figure 38.

It can be clearly seen from Figure 38 that the majority of success images were taken from approximately 6.5 to 10.5 hours into flight. This predictably corresponds with the ADCS tracking data and Flight Timeline. In addition to this, it can be noted that some successful Sun images were taken during ascent. Again, no science images were taken between approximately three and six and a half hours into flight as the payload was put into night mode.

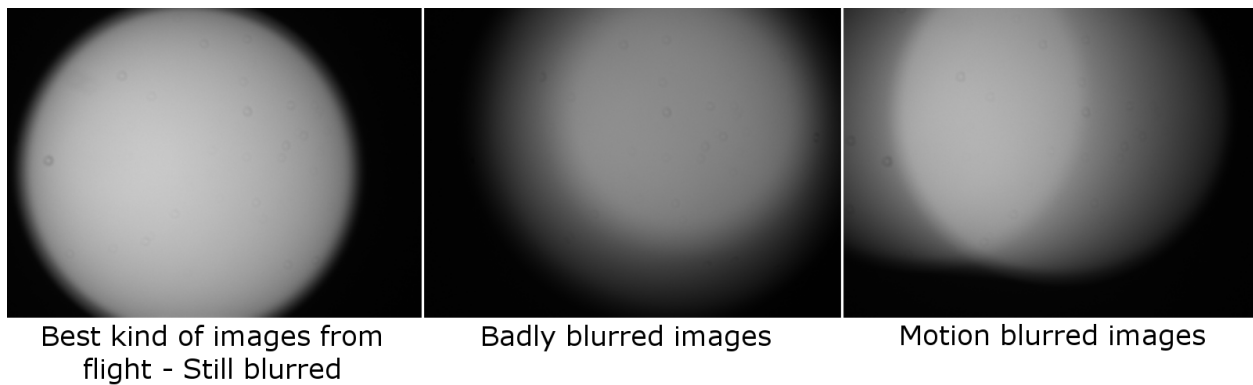
Figure 40: Sample Flight Images

Instead, due to the focusing problems that will be further discussed in the next section, the flight images were blurred in a variety of ways. A sample of the flight images are seen in Fig. 40.

The first image shows what the best images from flight looked like. They were still blurred on the edges, and were too blurred to show sunspots. These made up the majority of the images from flight. The second and third images are examples of more badly blurred images. These images were primarily taken in the first three hours of flight; the blur is likely caused by motion of the platform. Accelerometer data confirms this was the most unstable period during the mission. The Optics team believes that this blurring can be attributed to the motion of the gondola during flight. Motion blur can be characterized by asymmetrical smearing, which can be seen in both of the latter two images in Fig. 40. Such extreme motion blurring was never encountered during systems testing, making gondola motion the likely cause.

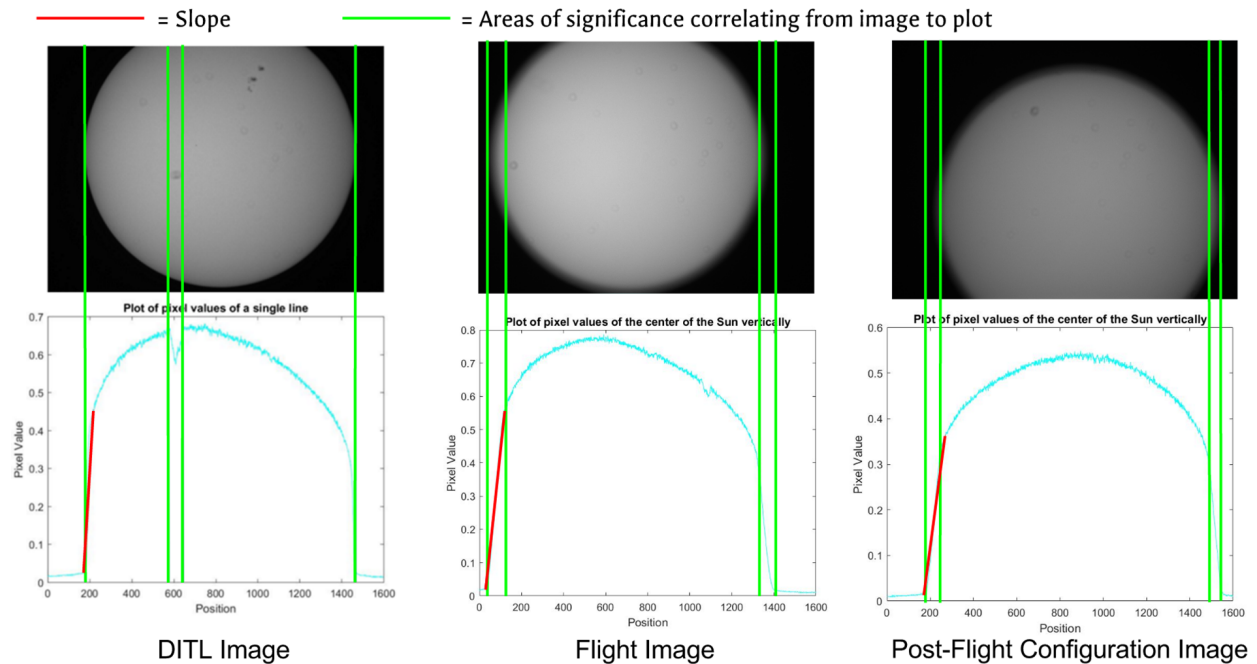
Figure 43: Comparison of Plots of DITL to Flight to Post-Flight

Figure 43 shows several sample images with their corresponding pixel plots. This figure includes a properly focused image from the second DITL test, as well as an image taken post flight as part of the optics failure analysis.

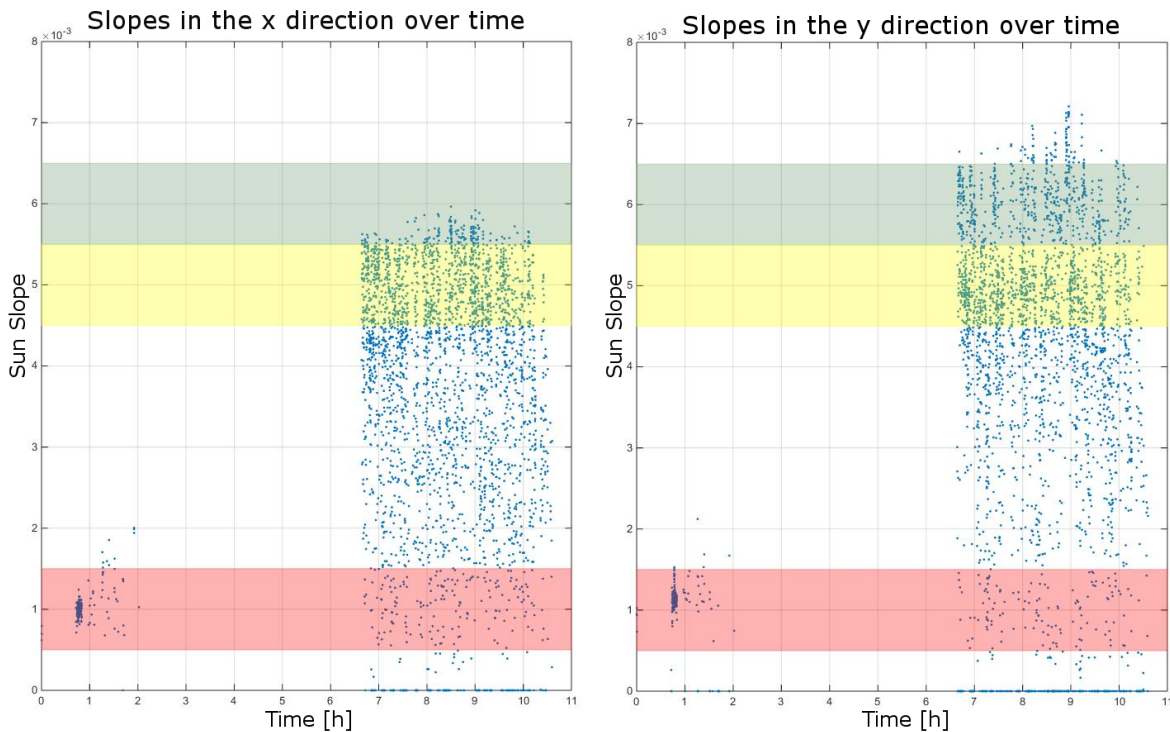
With the slopes found, the optics team was able to plot the slopes throughout flight to see if there was a trend. If the optics system had been properly focused, the team would have expected to see a positive trend between slope and time during the ascent portion of the flight. This is because the team expected the images to improve with altitude of the payload. The resulting plots can be seen in Fig. 44.

As noted previously, the Sun was out of the field of view for much of the ascent, so there is a gap from three to six and a half hours into flight. As seen above, there are three different highlights on the graph corresponding to three distinct types of flight images. These types or flight images are shown below in 45. Green images correspond to the best types of images that were taken throughout flight. They are sharper than yellow images which tend to be minimally distorted by motion blur resulting in smeared pixels. Finally

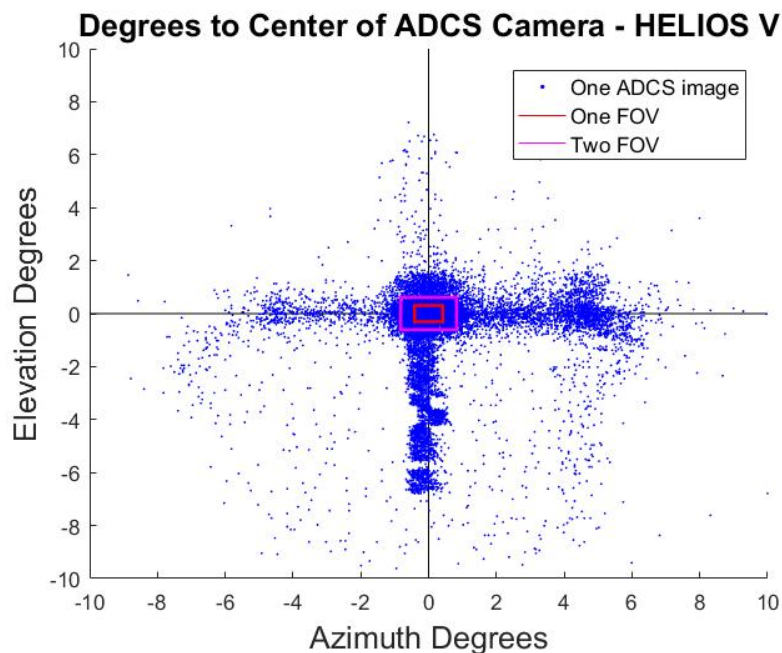
Figure 46: Scatter plot of the degrees from the center of the Sun to the center of the ADCS camera.

The goal of the subsystem was to produce the most images within the field of view of the science camera as possible. In total, 43% of the science images taken met this criteria, and 76% were within twice the size of the field of view.

The "tails" off of the main group are a byproduct of the modified tracking algorithm. When the payload lost track of the Sun, it quickly panned up to the maximum, then slowly scanned down until it found the Sun. During this slow scan downwards, clumps of images spaced in roughly one degree increments were taken.

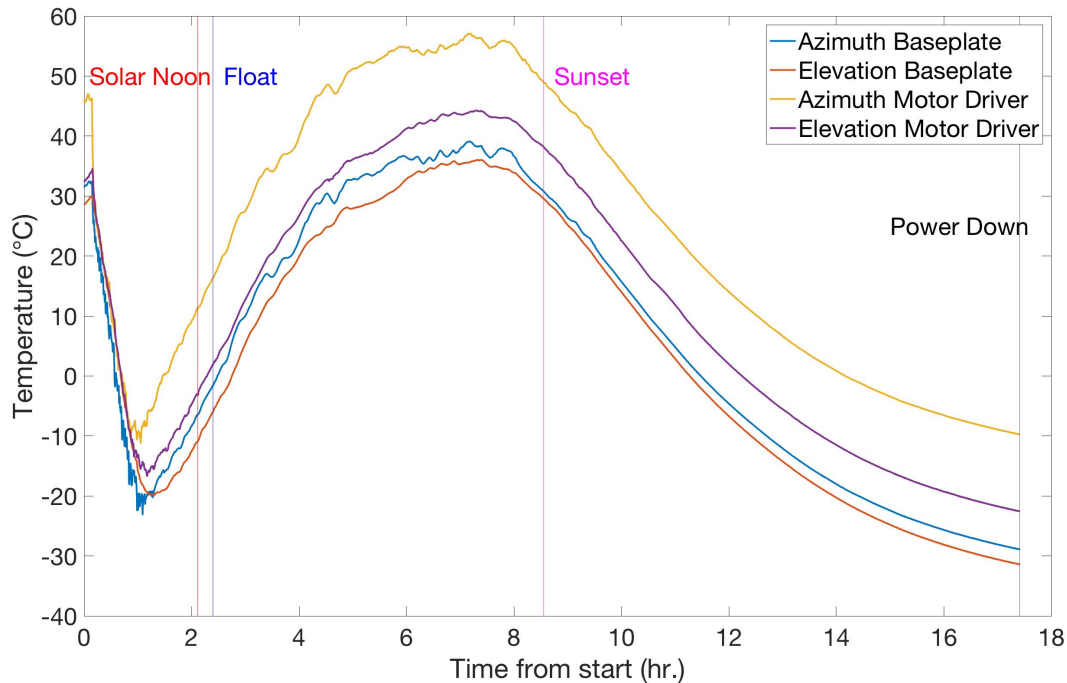
Figure 47: Graphical illustration of successful heatsink

From previous HELIOS missions and testing, it was determined that the motor drivers which control the motor movement generate a significant amount of heat. Because these components were directly attached to the EPS board, it was necessary to draw the generated heat away from the board to protect the circuitry. One end of copper braid was attached to each driver, and the other end was attached to the base plate with a thermal compound. As seen in 47, the azimuth and elevation base plate reached a maximum temperature of 57°C and 44°C , respectively. The copper heat sinks effectively reduced the heat of each by around 10°C, keeping the azimuth and elevation drivers at a safe temperature of 39°C and 36°C, respectively.

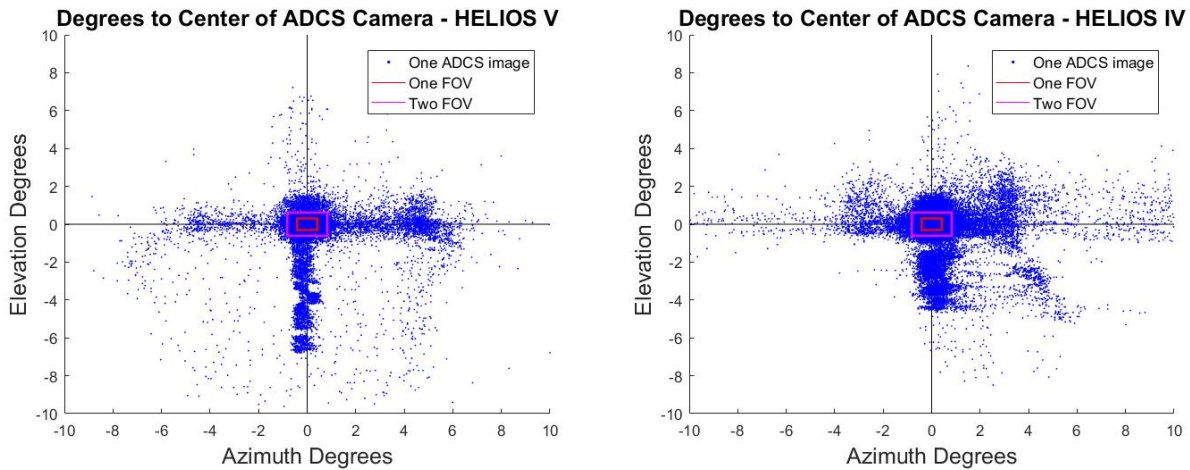
Figure 49: Comparison of density of Sun center in tracking images

The scatter plots in Fig. 49 show the center of the Sun compared to the FOV of the science camera, as captured by the ADCS camera. 43% of the tracking images taken by HELIOS V were within the FOV of the science camera. A similar plot was constructed for the data from HELIOS IV using the same success

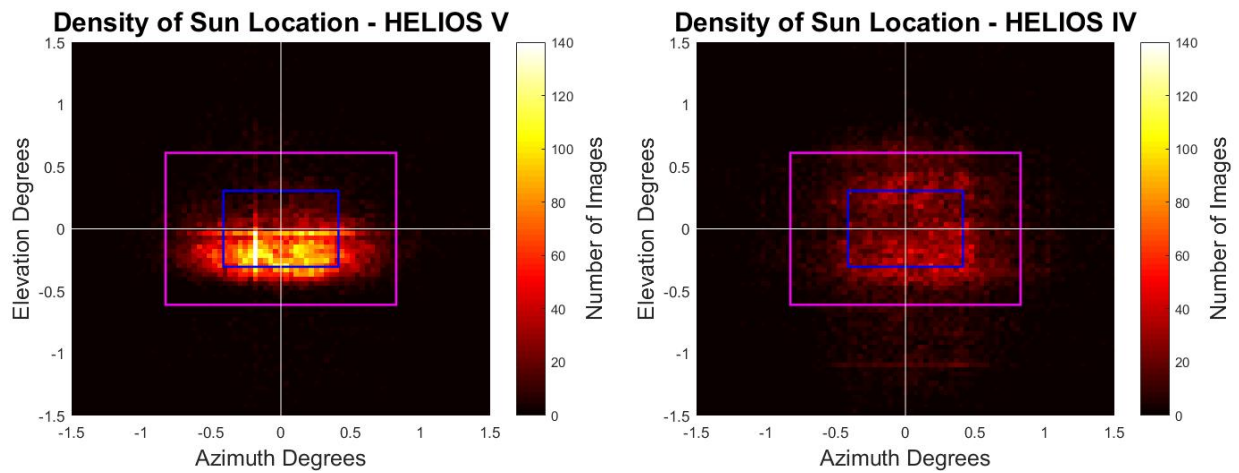
Figure 50: Comparison of density of Sun center in tracking images

The heat maps in Fig. 50 show the density of the location of the center of the Sun in all of the tracking images. Compared to HELIOS IV, HELIOS V had a greater density of Sun centers in the successful range, which is again shown in terms of FOV of the science camera. While the low density for HELIOS IV is due to the fallen counterweight, the results from HELIOS V show that without the failure mode of the fallen counterweight, the tracking system from HELIOS IV could have tracked the Sun equally well. Both HELIOS V and HELIOS IV show a tendency to track towards the bottom of the FOV of the science camera. For future missions, this could be corrected by changing the elevation bias on the ADCS camera so that it centers itself at a steeper angle.
