West Virginia University
High Altitude Cosmic Radiation (HACR) Detector
Payload Summary and Flight Science Report

Department of Mechanical and Aerospace Engineering
West Virginia University, Morgantown, WV 26506/6106

12/20/2007

Abstract

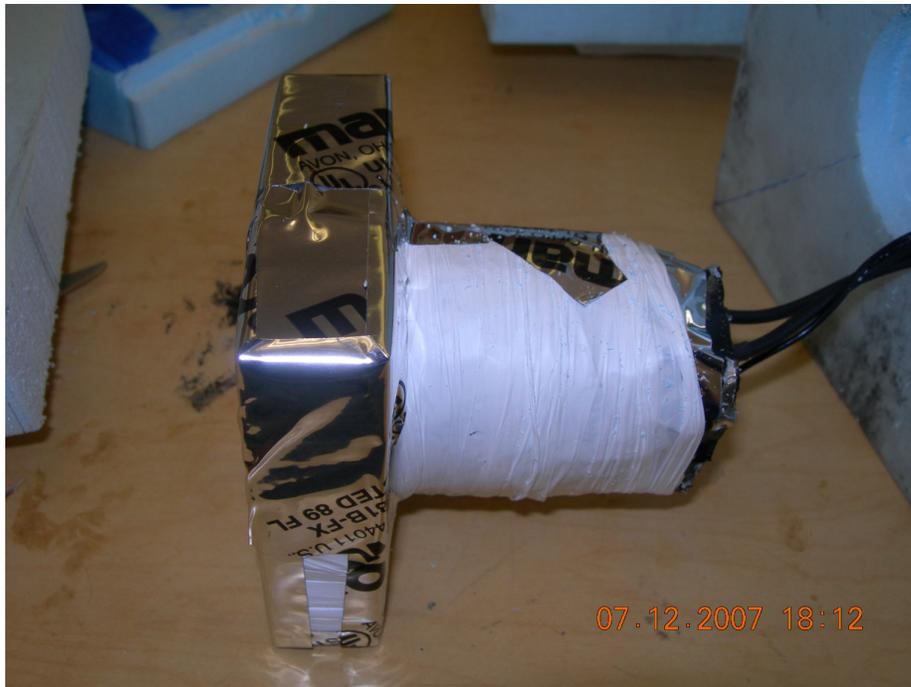
Figure 3: Single Light Tight Detector Assembly

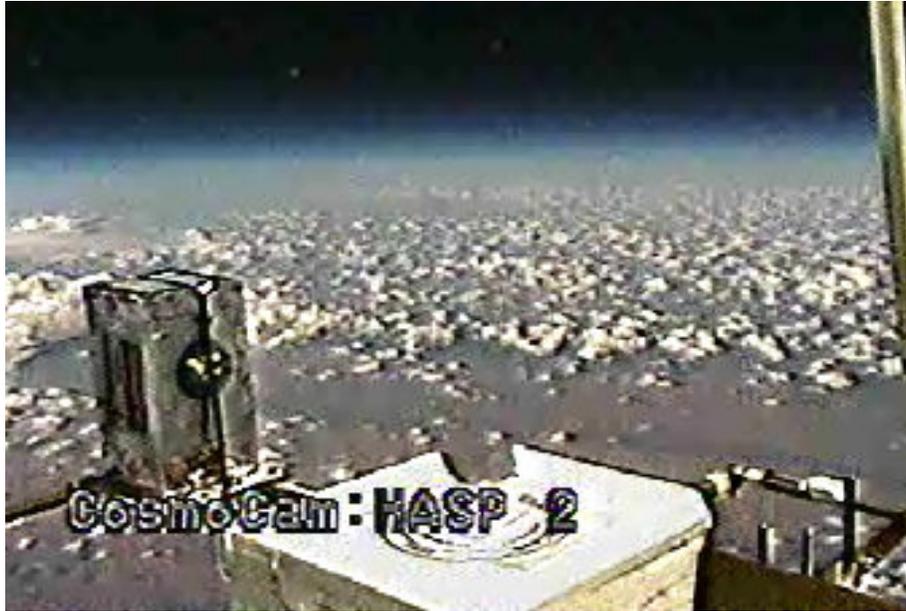
Figure 8: Completed Payload at Float

A less severe failure was the payload unexpectedly repeating its startup cycle throughout the flight. It is believed this was due to power lapses from the HASP platform supply; however, data was not sampled fast enough to catch these lapses. A final failure experienced during the flight was the replacement of the lead character in all data strings with a random character. As with the entry into the testing mode, the cause of this failure is unknown, but likely due to a high-energy ion or neutron strike in the upper atmosphere. The likelihood of these failures being the result of an ion strike is highly probable as has been found in other studies, such as a 1998 study of neutron strike effects on avionics conducted by Boeing (5). Even with these failures, the payload collected good data for 11.3 hours. This data included the ascent and 9.2 hours at float. Figure 8 shows an image from the CosmoCam of the completed payload during the flight.

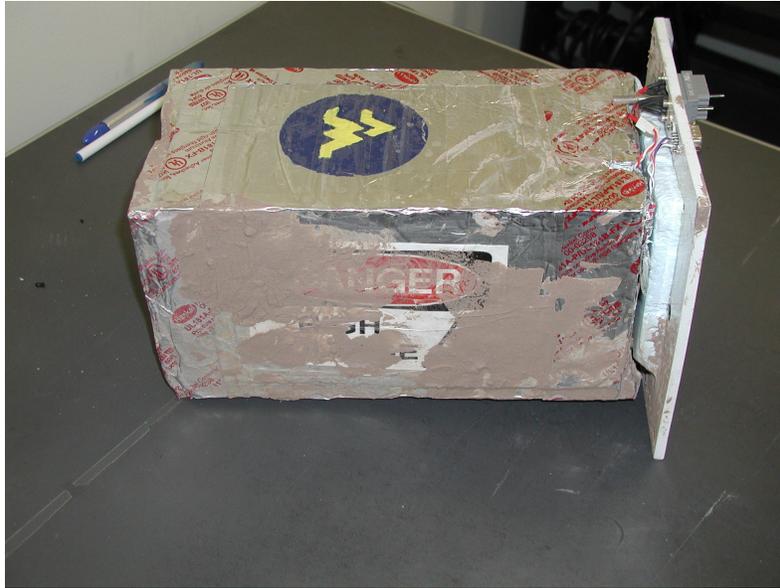
Figure 9: Payload after Recovery

After the flight the payload was inspected for signs of malfunction. Several items were noted; however, none should have caused a serious problem. The package showed signs of harsh mechanical treatment during landing and recovery, as can be seen in figure 9. The outside of the box was covered with mud, the box bottom plate was disconnected for the main outer shell, and the 10 Ω current limiting Dale resistor, which was mounted externally, was found inside the package.

The connections between the board and photomultiplier tubes had been strained and the dielectric epoxy showed signs of chipping. No exposed metal could be seen and no signs of arcing were present. All the solder connections (except those under the high dielectric epoxy) were inspected with a magnifying glass for signs of bad connection. None were found. There was some oxidation on the copper traces and solder mounds around through holed and surface mount connections; this was likely the result of the HASP landing in a freshly irrigated field in Southern California.
