High Altitude Student Platform (HASP) 2016

Electrostatic Comic Dust Collector (ECDC) Science Report

College of The Canyons
26455 Rockwell Canyon Rd
Santa Clarita, CA 91355

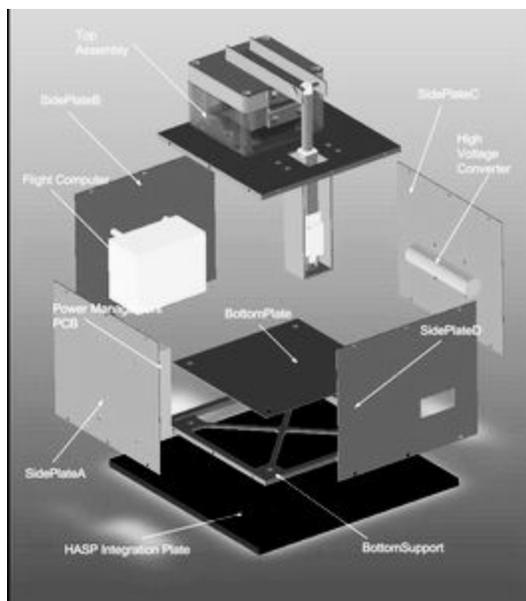
Figure1. ECDC payload CAD design

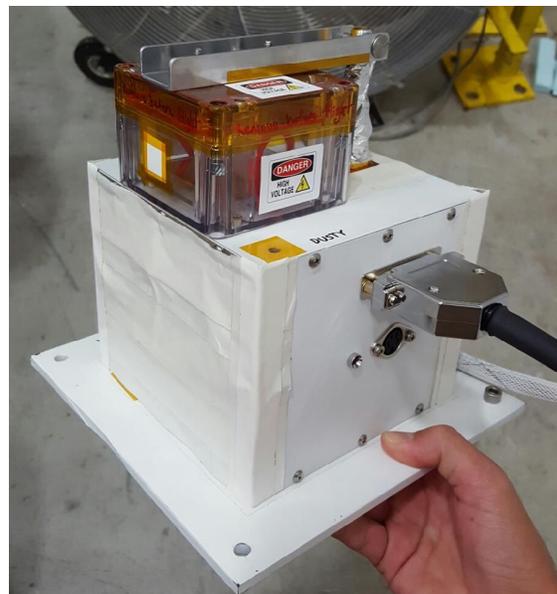
Figure2. Flight-ready ECDC Payload (Aug. 2016)

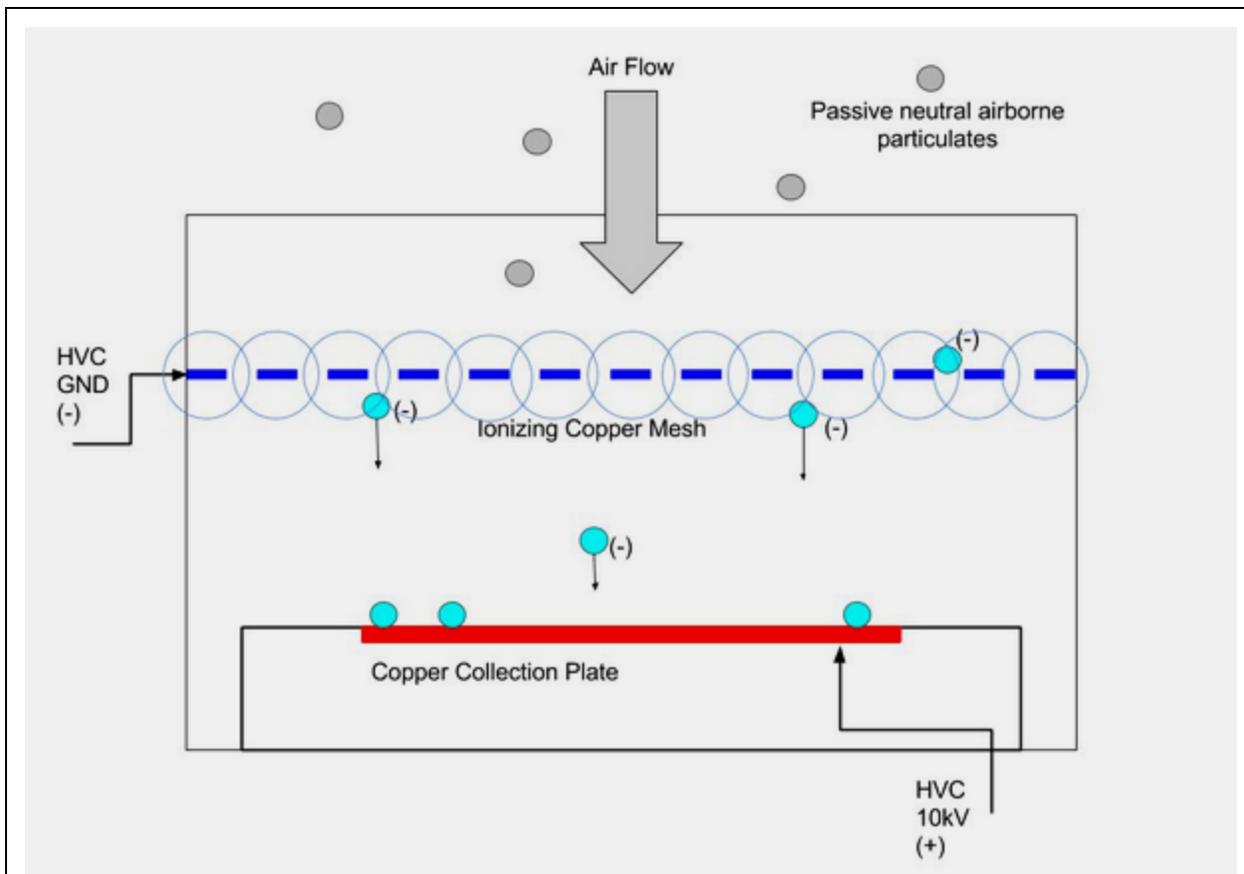
Figure3. Electrostatic particle collector concept diagram

The way the electrostatic particle collector works is the same basic concept as an electrostatic precipitator found in most large air filtering systems of buildings. A high voltage, 10kV in our case, is given to a large electrode that has the task of collecting the dust particles. The ground of that same high voltage supply will be connected to another electrode away from the collecting plate and in front of the incoming stream of air. This grounded electrode will then give a strong negative charge, capable of ionizing any particles that come in with the air flow. Once the particles become ionized, they will accelerate towards the positive collecting electrode and “stick” to the plate. The negative electrode in our experiment was chosen to be a copper mesh, the best form to not impede air flow yet still achieve maximum ionization with smaller gaps between the ionizing wires. The collection plate is a simple copper plate placed 2.5cm below the mesh that will gather the particles after ionization.

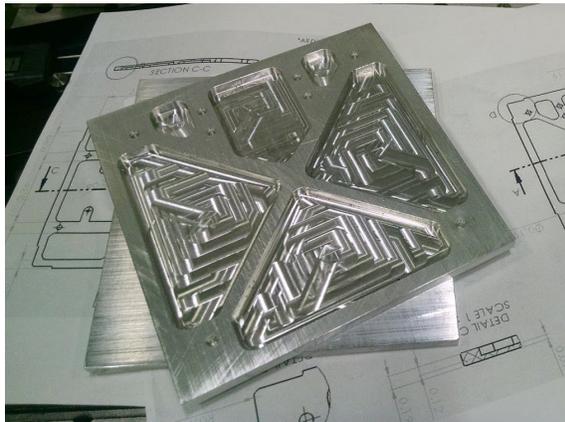
Figure4. CNC-milled bottom support plate

Being a team from a community-college, there were workforce training facilities on campus that allowed for advanced manufacturing to be done on the payload mechanical systems. This allowed us to build two separate mechanical payloads with one being used for testing and the other for flight. By that approach, all parts were created and tested by building the test article and the flight article received only the highest quality and most-refined parts from the fabrication. Lightweight aluminum 6061 was used for the top and bottom plates of the payload while rigid aluminum 2024 panels and 6061 side extrusions supported the payload structure. The plates were milled with a CNC mill to create weight-reduction pockets which cut the weight of both plates down by 54%. This lightweight and simple payload structure, once completed, turned out to be much more robust and shock-resistant than previously anticipated. However, this system did undergo major design changes throughout the dynamic project timeline.

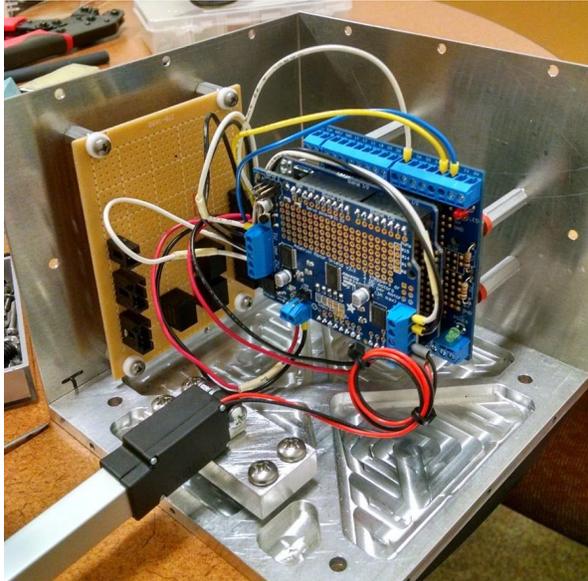
Figure6a. Flight computer, power management board, electronics & motor assembly configuration.

The payload electrical systems were designed to be run on a programmed Arduino Uno with additional "shields", or stacked PCB's that expand the functions of the Uno. This simple and modular design gave the team the ability to stack different PCB's with unique functions to control onboard payload systems. The Uno also had the added benefit of having a compact size that was able to fit into the standard small-payload class size restrictions of 15cm x 15cm. The flight computer was powered by a custom-designed power management board (PMB) capable of converting the 30VDC given by HASP into the various voltages needed by the payload systems. The PMB was located on an adjacent panel from the flight computer and was wired to the computer through a molex connector bus. The PMB also housed the HASP power and discrete signal interface, heater power control, and the high voltage power converter. The board was soldered together using a prototyping board that was suitable for the purpose of a simple power interface capable of surviving the environment expected during flight. The wiring schematic proved to be a downside of the proto-board with the amount of wires being needed becoming a hassle to solder and route.

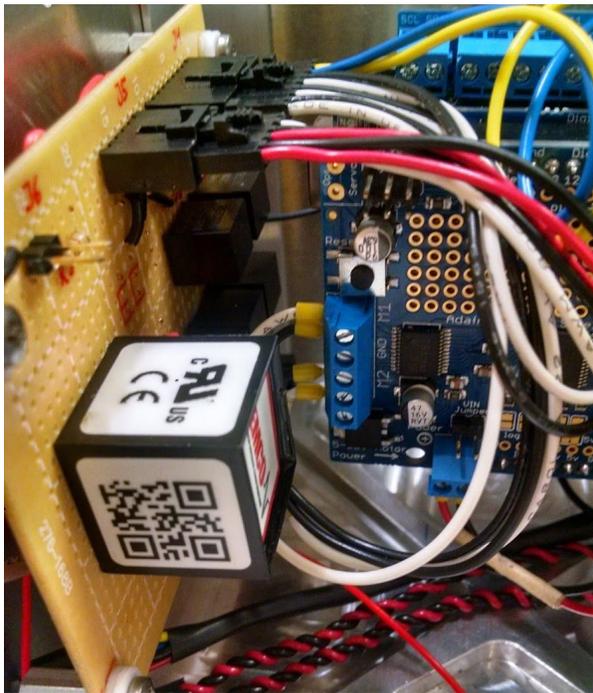
Figure6c. Flight computer and power management board proximity and wire interconnections.

An unanticipated problem that began to arise as fabrication in its final stages was the large amount of wires inside the volume of the payload. As seen in figure6c, it became difficult to mount the electronics on the enclosure panels in such close proximity considering the wire interconnections between the flight computer and the power management board. This problem caused more wire and connector strain than was anticipated and caused the design to change slightly by moving PCB mounting holes further apart from each other in order to space the boards further apart.

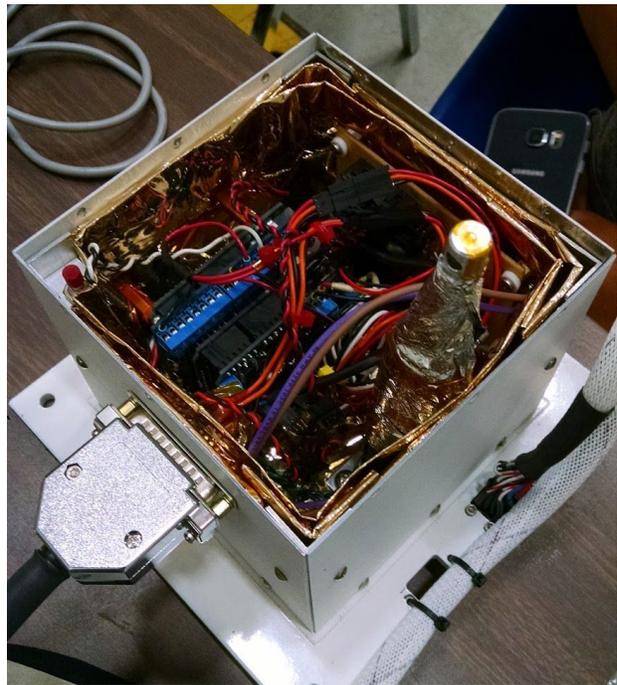
Figure6d. Assembled flight payload with flight components and insulation

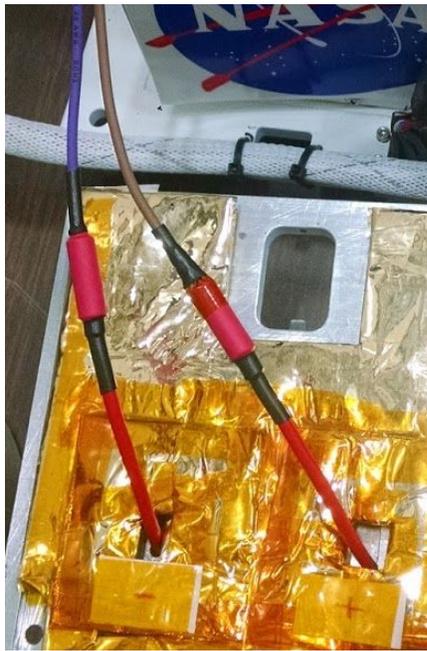
Figure7a. High voltage splice insulation

Since the design called for the connect/disconnect of the high voltage wires to swap out the test EPC enclosure for the flight EPC enclosure, there needed to be a safe way to ensure a discharge-safe interconnection of the high voltage wires. Connectors rated for high voltage applications proved to be too bulky, heavy, and expensive to use on our payload. The solution was to use a wire splice secured with a layer of Kapton tape and enclosed in a teflon sheath repurposed from a PCB standoff. This was then layered in shrink-tube to prevent moisture and particulates that cause discharge to occur.

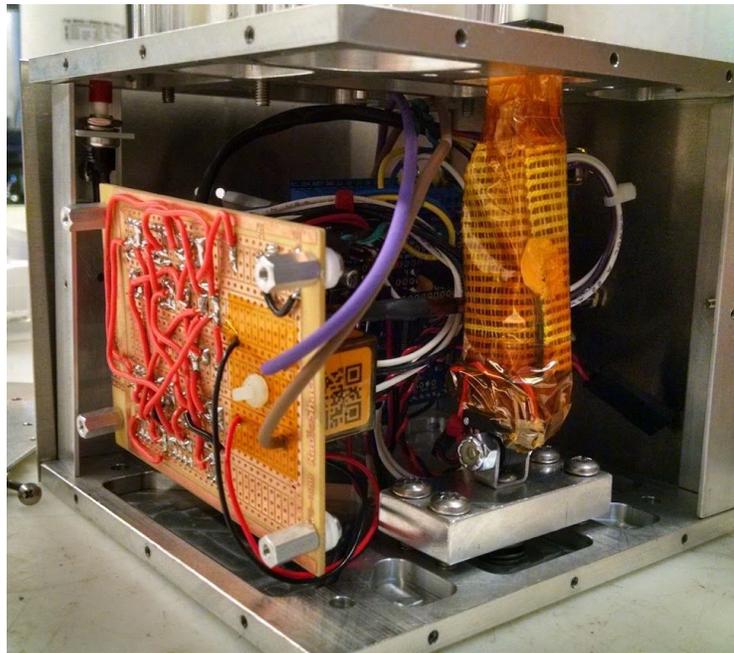
Figure7b. High voltage wire path (purple & brown) from PMB to EPC enclosure above

A serious concern of members of the ECDC team and the HASP personnel was the use high voltage in the experiment. A charge of 10kV was applied to the positive copper plate with a coinciding ground wire from the high voltage converter going to the copper mesh. This high voltage needed to follow close examinations and major precautions to prevent arcing in a low-pressure environment that could fry payload electronics or even worse HASP electrical systems. Therefore, 15kV rated wire was used for the high voltage transmission and creepage/clearance distances of more than 2.5cm were included in the assembly designs.

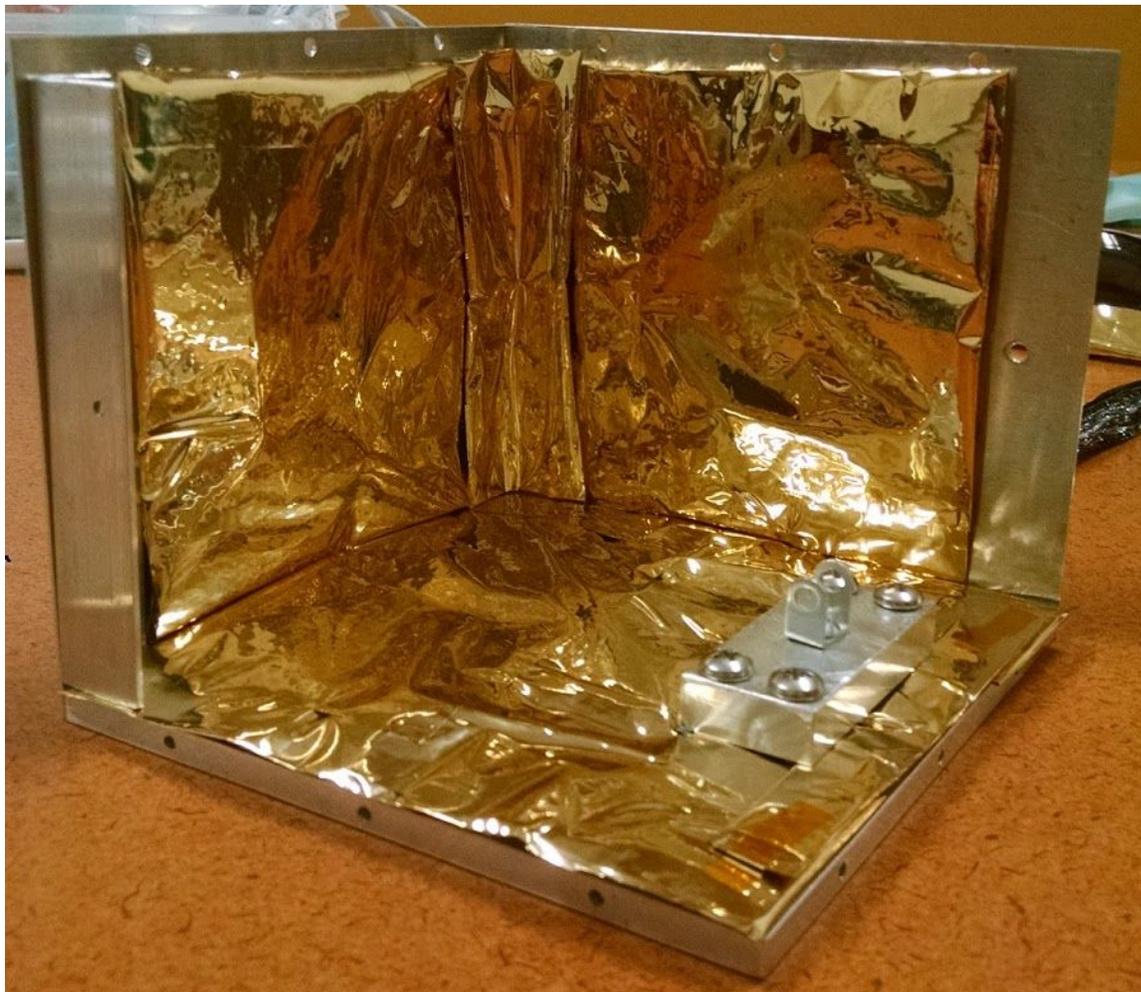
Figure8. Reflective mylar and aerogel blanket insulation used in the PTC system

One of the most surprisingly successful systems implemented on the ECDC 2016 flight was the thermal protection system that protected the payload from the temperature extremes of high altitude. The Active Thermal Control (ACS) system was comprised of an array of 5 temperature sensors and 1 heater that monitored and heated vital temperature-sensitive systems. The Passive Thermal Control (PTC) system was comprised of layers of mylar insulation (figure 8.) paired with an aerogel blanket covered in additional mylar. Both systems performed admirably during the flight, but had their drawbacks during fabrication as well as flight.

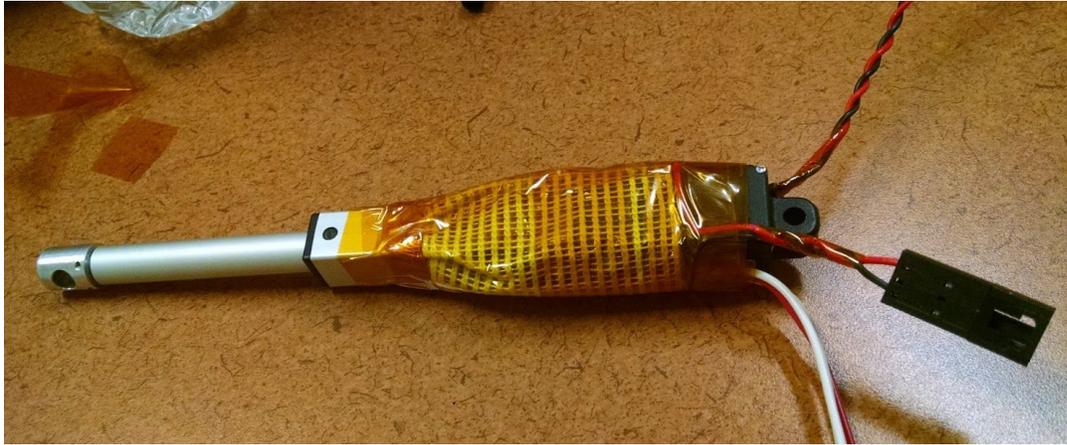
Figure9. Actuator with heating pad and temperature sensors installed

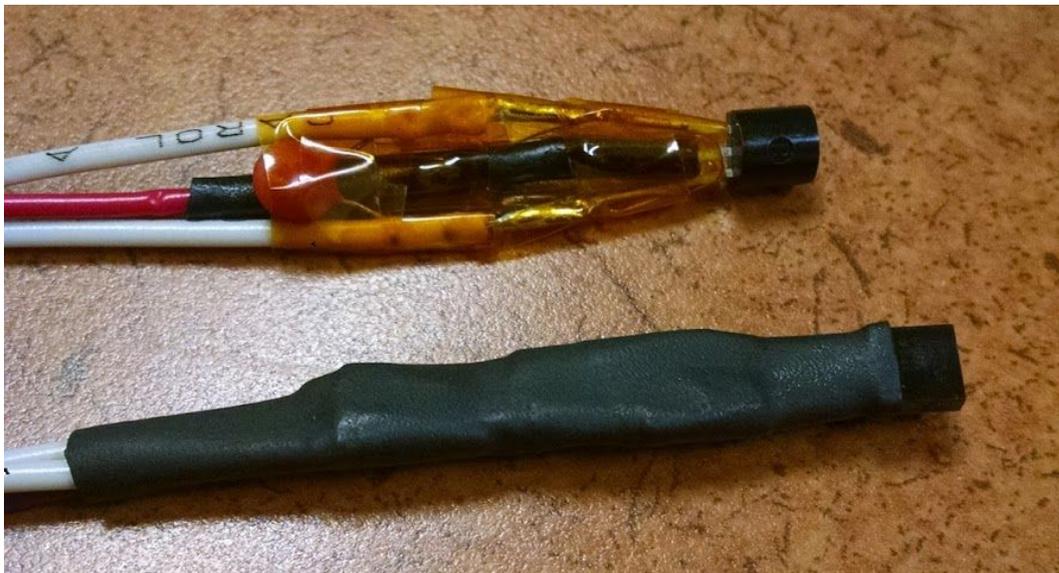
Figure10. TMP36 temperature sensor internals

The ATC system used one of the most common and resilient temperature sensors on the market: the TMP36 analog temperature sensor. The sensor was small, lightweight, and simple to use since the analog voltage output was the exact temperature of the surroundings in degrees fahrenheit divided by 100. These sensors were used to monitor the temperature of the HVC, actuator, and flight computer ambient; along with an additional two sensors that gave analog temperature readouts to the analog downlink stream. The TMP36 has a minimum temperature tolerance of -40°C before it begins to act abnormally; it was assumed that exceeding the minimum temperature requirements would not cause a failure of the sensor.

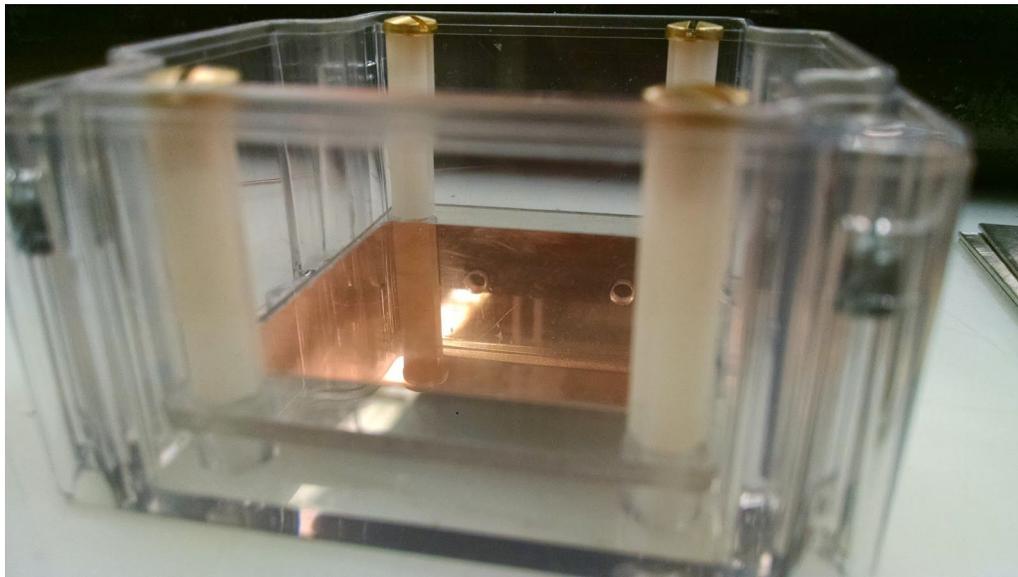
Figure11. Secured copper plate assembly in the test EPC enclosure

The wiring of the collector required the use of a potting epoxy to create two wire feed-throughs into the bottom of the enclosure. Two holes were drilled in the two thickest boss extrusions to ensure that the epoxy had the most surface area to adhere to. The potting resin was originally bought to be used in a high voltage converter enclosure before the idea was scrapped. Therefore, the resin had a very low viscosity meant to fill any gap but proved troublesome for our new purposes. Once cured, the resin was found to hold strongly and created a good barrier against dust contaminants. The wires that were fed through were then attached to the copper mesh and copper collection plate. The wire that energized the mesh used a crimped connector that was screwed down using the brass screws to provide a strong connection point. The wire that energized the plate went through some trial and error before settling on a final design. Soldering proved too difficult since the thermal conductivity of the plate was so good, it would not be able to heat up to the temperatures required for soldering before the ambient room temperature stabilized the temperature. The solution that was devised was to tape the frayed high voltage wire to the plate directly and glue the plate into the holder with a two-part cement epoxy.

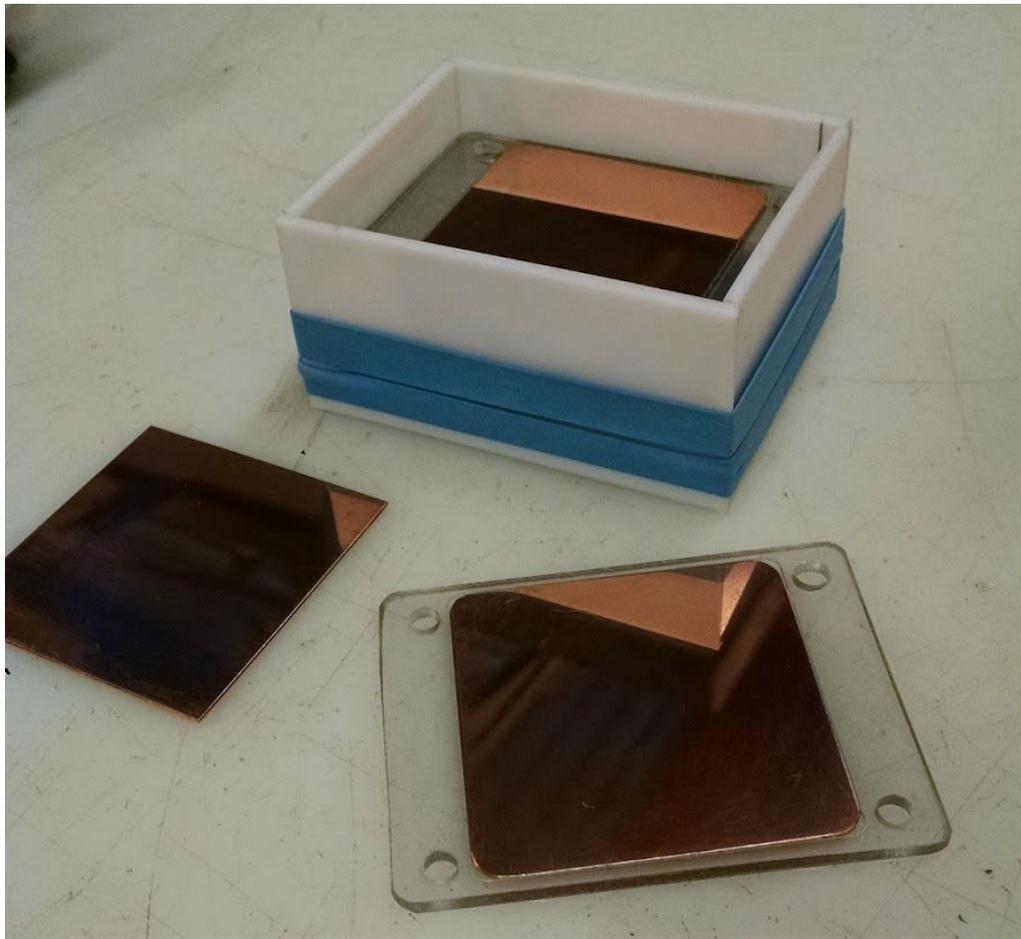
Figure12. Copper plates polished to 100-microns and acrylic pouring mold

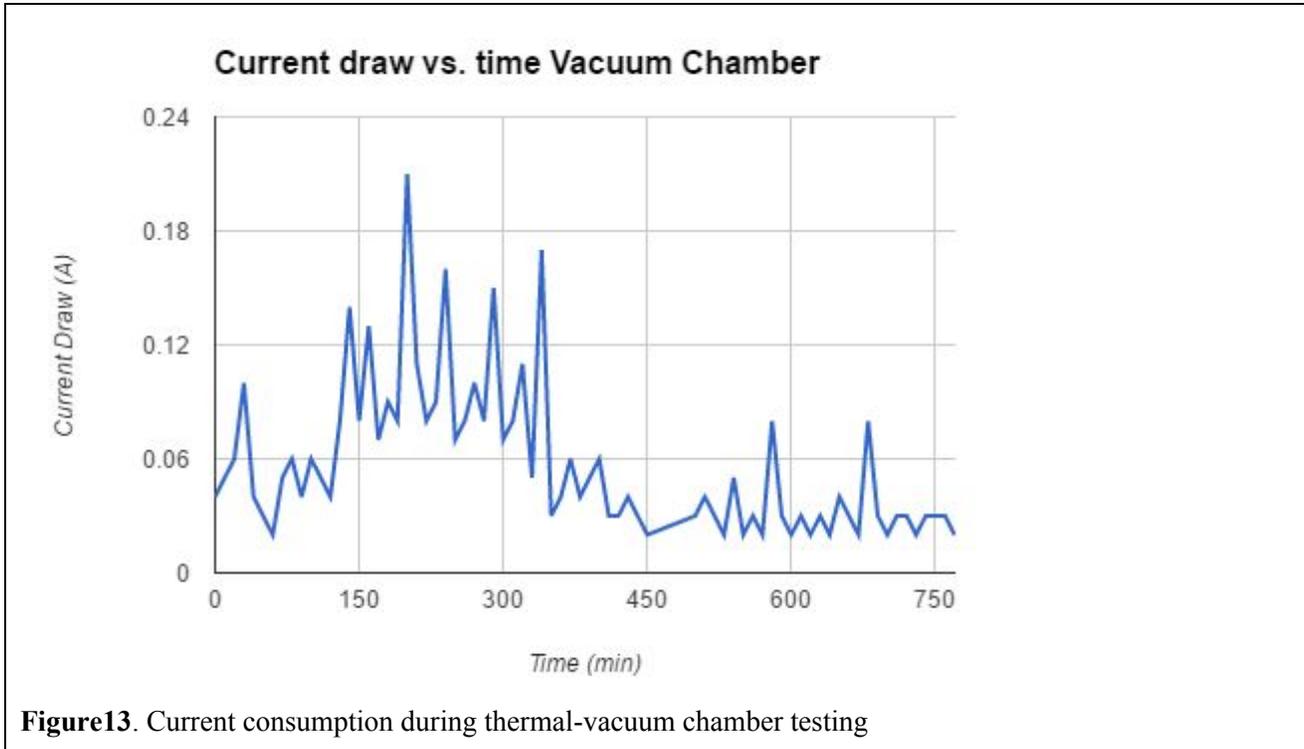
Figure13. Current consumption during thermal-vacuum chamber testing

During thermal vacuum testing, current consumption was recorded by hand from the incoming HASP housekeeping stream and recorded by the team in a graph of current draw over time. As seen in the graph, current consumption was highest during the cold-test between 100 and 400 minutes since start of the data stream when the temperature was pulled down to -50°C . This showed the team that the active thermal control systems were active and warming the motor to prevent freezing. During the hot-test in the time period between 400 and 700 minutes, the temperature was then pulled up to $+50^{\circ}\text{C}$. There were a few current spikes that were expected when the discrete signals were sent to activate the linear actuator. The EPC enclosure was opened and closed twice during the hot-test and the cold-test with success in all 4 discrete signal tests. After the thermal-vacuum test, the test EPC enclosure was swapped for the flight EPC enclosure that had been cleaned at the CSUN cleanrooms and identical to the test article used in testing. After a final inspection by the team, the decision was made that the payload was prepared for flight and was handed over to HASP personnel with flight certification complete.

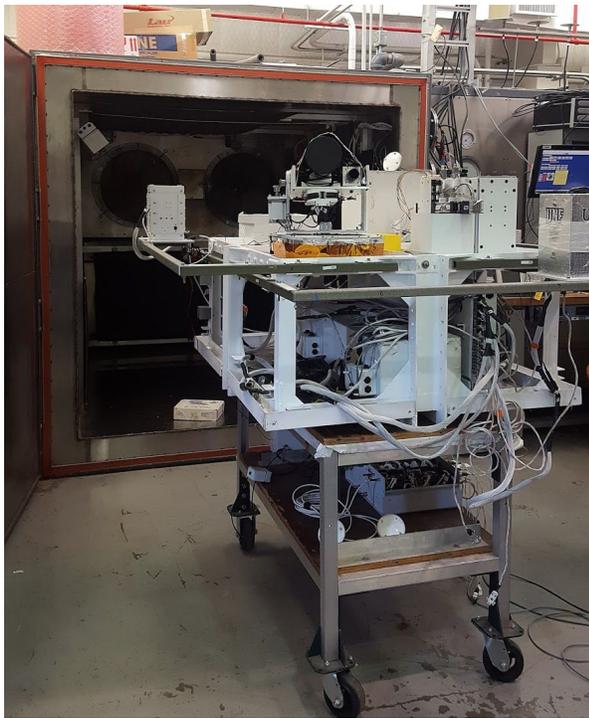
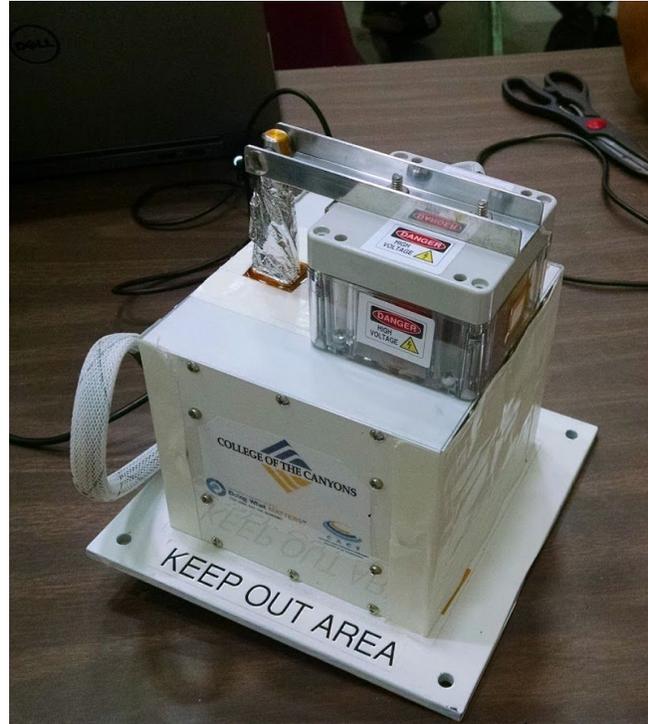
Figure 14. Thermal-vacuum chamber with HASP **Figure 15.** Payload with test EPC enclosure

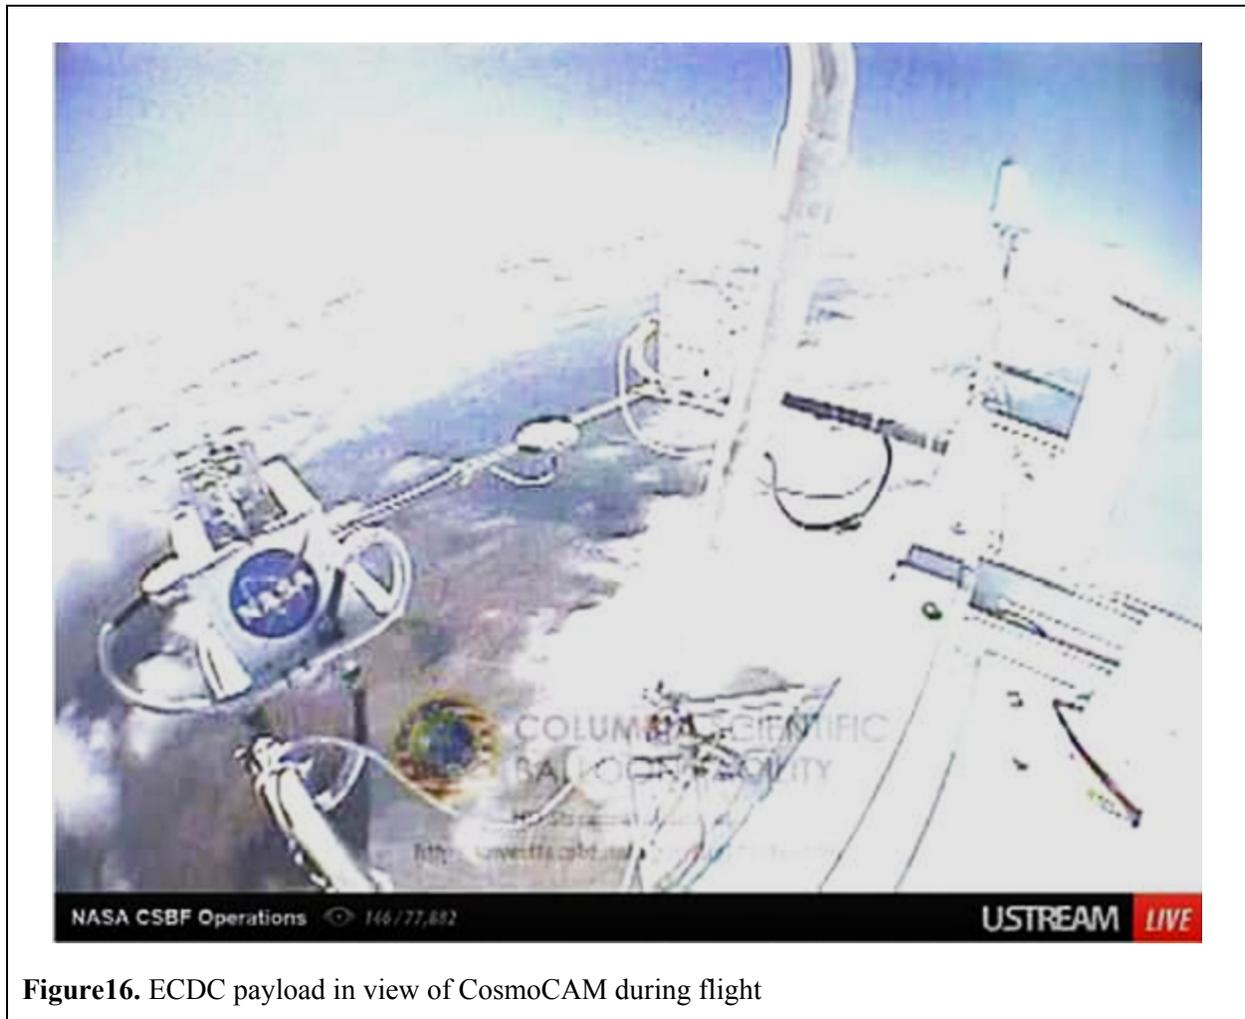
Figure16. ECDC payload in view of CosmoCAM during flight

The team's main source of payload status monitoring during flight was the current fluctuations recorded by the HASP system housekeeping data tables. These data tables were updated in a near-live data stream that could be accessed by anyone on the LSU HASP webpage. This data was closely monitored by members of the team throughout the entire flight with the exception of the power shutdown that occurred just prior to nightfall. One of the main status-monitoring streams that needed to be watched was the CosmoCAM video stream that was provided for the flight by the CSBF team.

In an unfortunate turn of events, the camera failed to send a video feed down after about half an hour into the launch of the platform. After a while of dead signal, the ECDC team contacted the HASP officials for a status update on whether or not CosmoCAM would come back online. The answer was that the camera was likely not going to come back online for the duration of the flight and that alternative forms of status-monitoring had to be utilized.

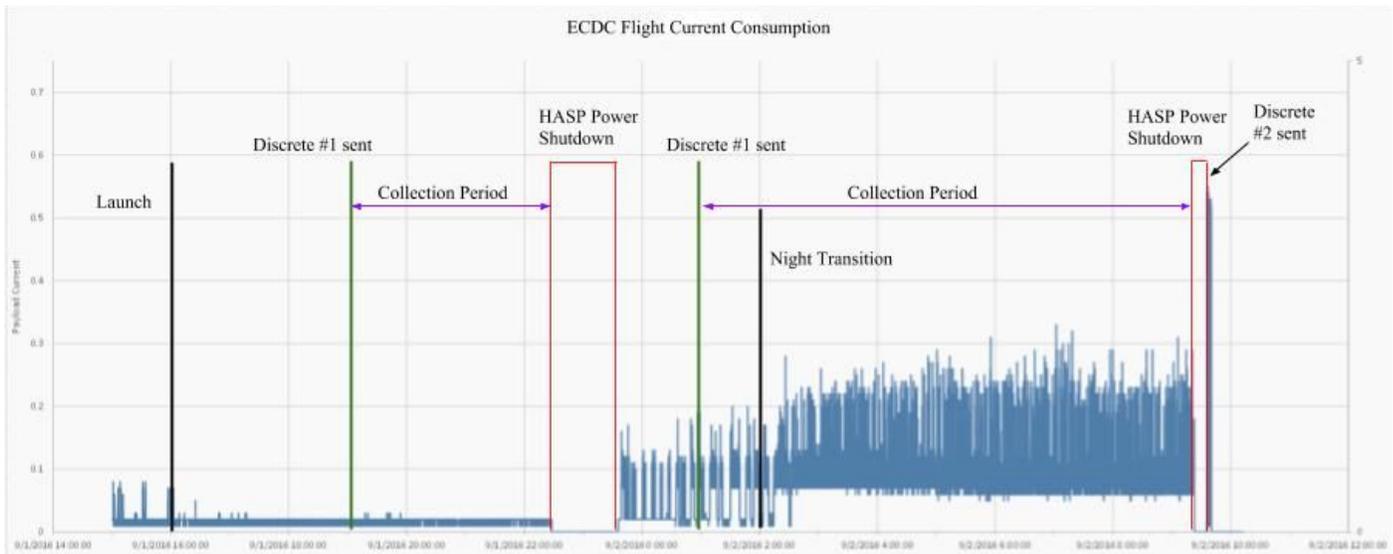
Figure17. Payload flight current consumption

These graphs of current consumption gave us the most accurate and most puzzling indications of how the payload was functioning. As seen in figure 17, the current consumption stays nominal from the time of launch until after the power deactivation at approximately 22:30 UTC, with some spikes observed before payload ascent. This power deactivation was a mistake made by the HASP flight personnel by following a command from payload #1 to deactivate their payload, and instead by misinterpretation deactivated our payload. The power was deactivated for about an hour from 22:30 UTC until 23:30 UTC. During this time, the high voltage converter had ceased working along with the electronics, but the EPC enclosure remained open. The team only noticed the power deactivation an hour after it had occurred and immediately began the procedure to notify HASP officials to turn power back on. Afterwards, it was assumed that the payload was operational again and continuing to collect particles. However, due to the power shut down, the flight computer did a full reboot of the flight software. The reboot meant that it did not remember any commands that were given to it earlier and continued to operate by default command: regulating temperature and collecting sensor data. We realized nearly an hour later that a following command needed to be sent to reactivate the high voltage that had been turned off. A secondary discrete command was received, processed, and sent one hour later to alleviate that problem and resume collection.

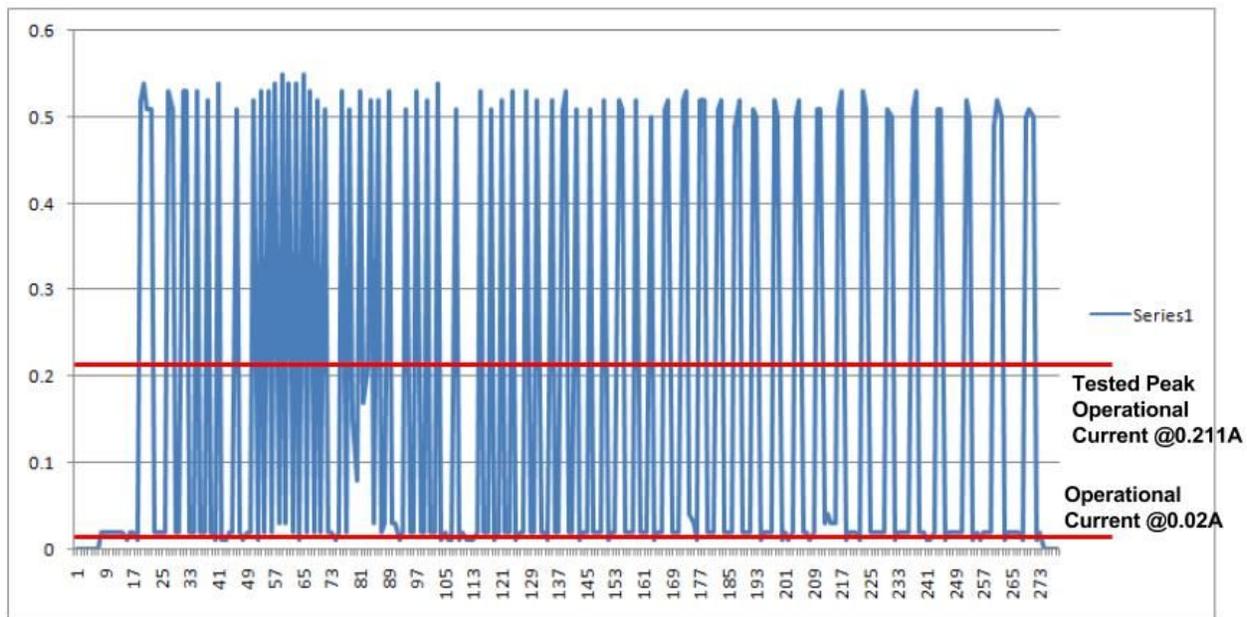
Figure18. Flight current anomaly (Current Amps x no. of data readings since power activation)

The most puzzling anomaly occurred at 9:36 UTC when the payload was powered back on after being shut down prematurely before termination. The team needed the payload power to turn back on in order to send the final discrete command to shut the EPC enclosure prior to HASP termination. The final discrete command was sent as soon as the power was activated again, during which time the high voltage converter was meant to shut down and the linear actuator would extend to close the collector. From recovery images, the EPC collector was in the closed configuration, proving that the command had worked successfully. At this time, it is very difficult to determine accurately what may have caused this current anomaly due to the lack of data discussed in section VI. It is possible that the linear actuator compressed as expected but somehow attempted to override the limit switch and keep pushing further causing it to reach stall current of $\sim 0.5A$ as specified in the manufacturer datasheets. Further testing would need to be performed in the future to avoid such large current spikes that can lead to blowing a fuse and ending the mission.

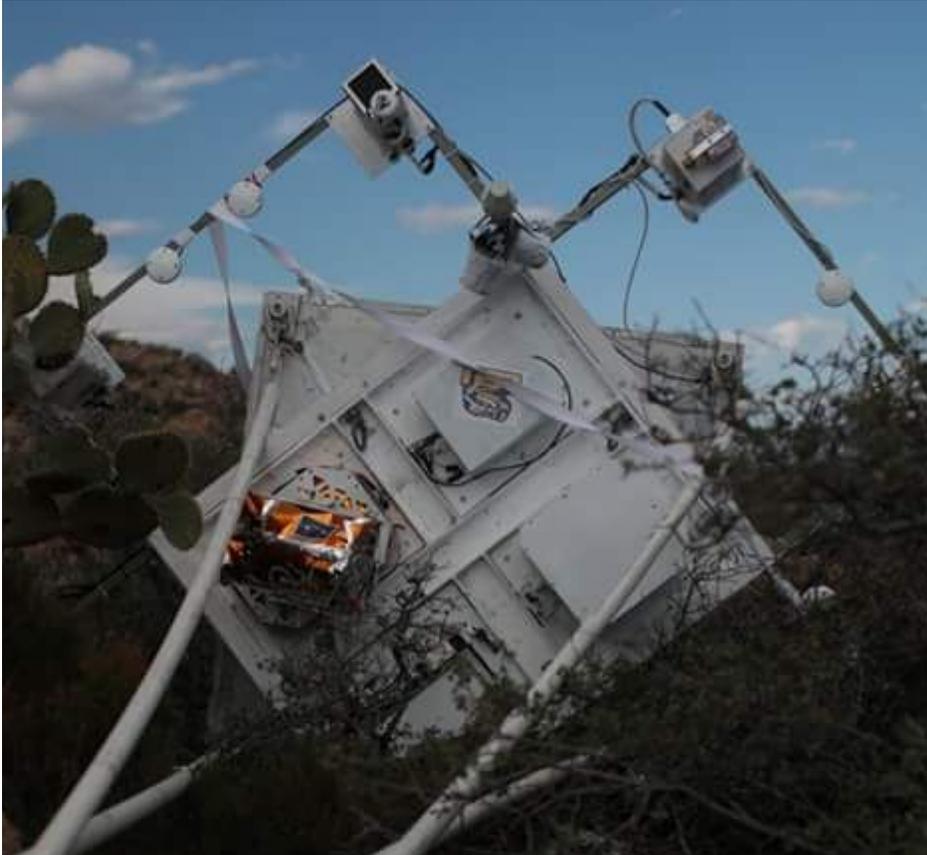
Figure19a. HASP landing side

The command for payload termination prior to balloon release and parachute descent happened on 9/2/2016 at 9:41:28 UTC. During this time, the power to all payloads was shut down and HASP was released for descent shortly after the platform cleared Phoenix, AZ.. HASP impacted at 10:27:05 UTC in partially-vegetated shrublands with large boulders spread around the area. Upon inspection of the images of the landed platform, it became clear that the ECDC payload did not experience any serious external shock or damage. In fact, the payload appeared to be the furthest from the impact against the ground, being located at the bow as opposed to the stern of HASP, which took the impact of landing against the ground.

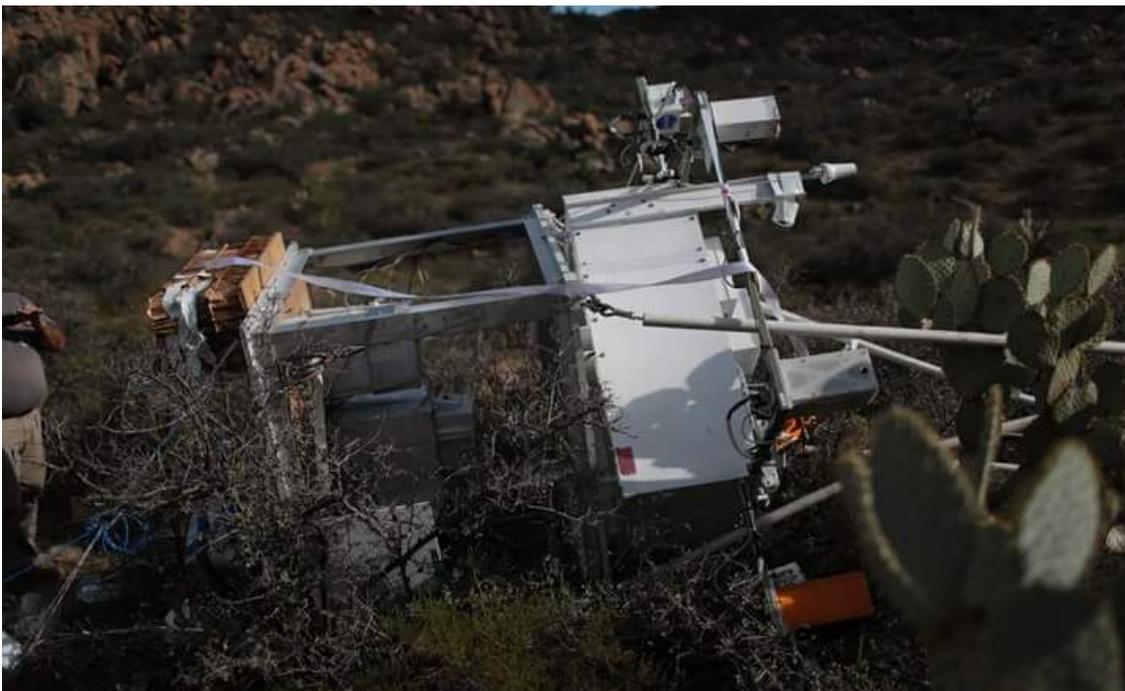
Figure19b. HASP landing front

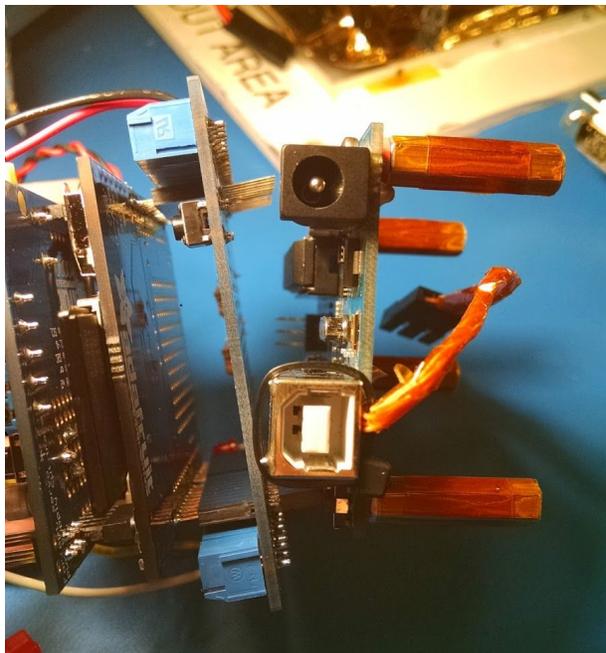
Figure 20a. Bent flight computer pins post-landing

The state of the rest of the payload proved to be less than promising. The issues began to arise when the USB interface cable was plugged in, giving the payload power for the first time since flight. The status LED remained off even though the computer showed that the flight computer was functional. When the serial interface with the computer was checked, it showed that the program was stuck in opening a new data logging file. The flight computer was taken out of the payload and the problem was immediately visible. The right-hand row of pins of the flight computer were completely disconnected and the left-hand row of pins were partially disconnected and bent to a 30 degree angle.

The right-hand pins were responsible for analog sensor processing, reset, and sensor power. The left-hand pins that remained connected were mainly responsible for communication between shields. This design flaw could have been easily fixed using a single zip-tie across the stack of shields in order to prevent disconnection.

- Flight Computer
 - The flight computer pin-disconnection issue was a foreseen issue that could have been easily addressed, but was forgotten during the final assembly of the payload during integration. What could have been done was to attach a set of zip-ties across the PCB stack to prevent them from becoming detached. A full and better-detailed list of procedures would need to have been written to avoid forgetting simple steps like these.

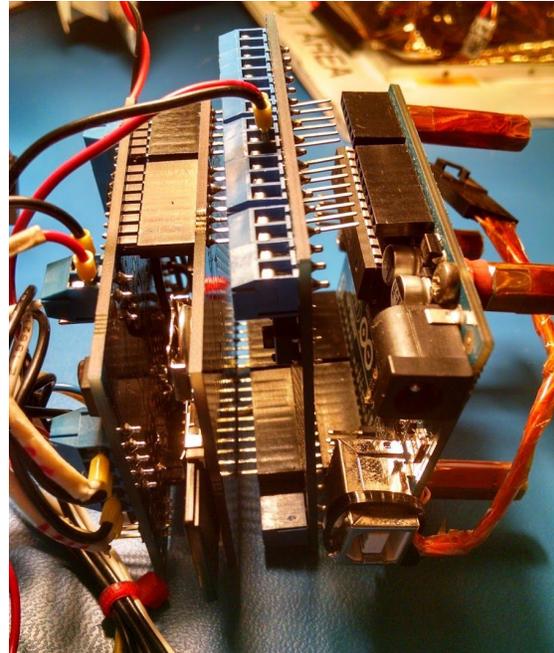
Figure 20b. Disconnected pins post-landing

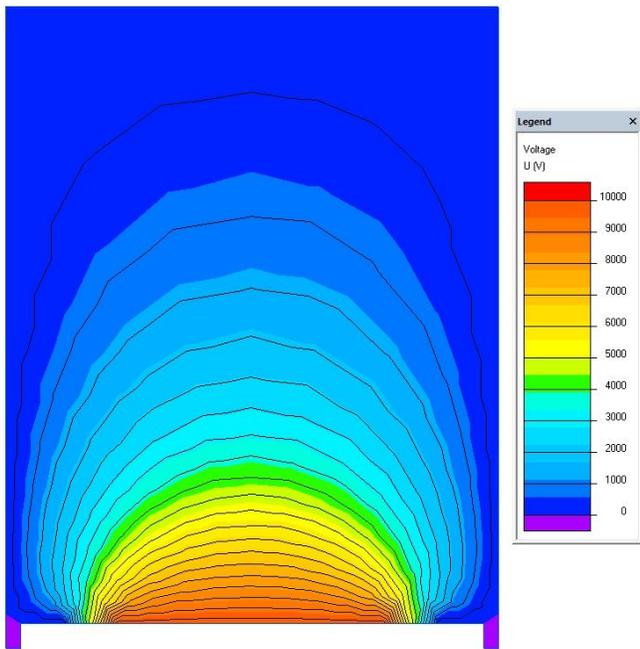
Figure 21a. Voltage potential model

The simulation models generated in Quickfield student edition as shown in figures 21a-21d, were generated to get a better understanding of the dynamics at play inside the collector mechanism. Unfortunately, with the student edition the number of nodes that are available to perform calculations were limited so only 2D cutaway models were formed with a limited mesh dimension. The data in figure 21a shows the electric potential of the 10kV voltage emitted from the plate at the mean pressure exhibited at 120,000ft. Figure 21b displays the electric field strength of the plate in that same environment. What was uncovered from the analysis of that model was that the majority of the electric field was concentrated at the outside rim of the copper plate. This fact was suggested, but was unable to be confirmed by the

team during the design phase. The high voltage electric breakdown concentrates around the sharpest points of an electrode where the electrons are more easily able to create an electron avalanche and ionize the air around that vicinity. This relatively higher electric field will in that case attract more oppositely charged particles that were previously ionized by the copper mesh. These electric field emitting regions gave the scientific analysis team a better prediction for where the particles may have accumulated at the greatest concentrations.

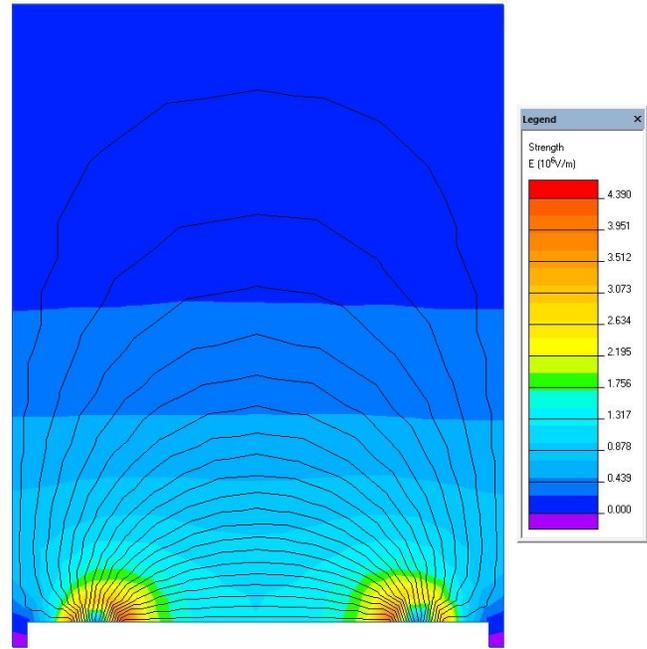
Figure 21b. Electric field strength model

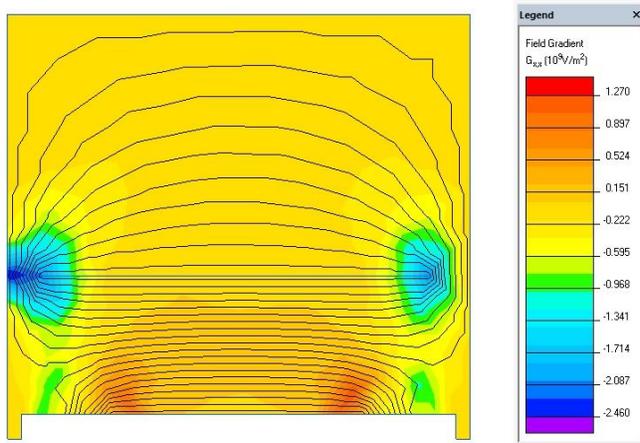
Figure 21c. Electric field gradient model w/ mesh

Figures 21c and 21d were then modeled with the thin copper mesh included, displaying the field gradient and electric field strength. The field gradient was able to give us a good overall representation of where the negative charge was produced and where it was collected on the relatively positive plate. The field strength model was able to illustrate how the particles would travel once they have been ionized by following the electric field from the mesh to the collection plate. One major concern in this was since the design called for the potential between the mesh and plate to be so high at such low pressures, arcing would occur between the two electrodes. Paschen curves needed to be analyzed and showed that with a spacing of 2.5cm at ~0.01atm and 10kV potential, arcing would not occur since that point was below the line of voltage breakdown.

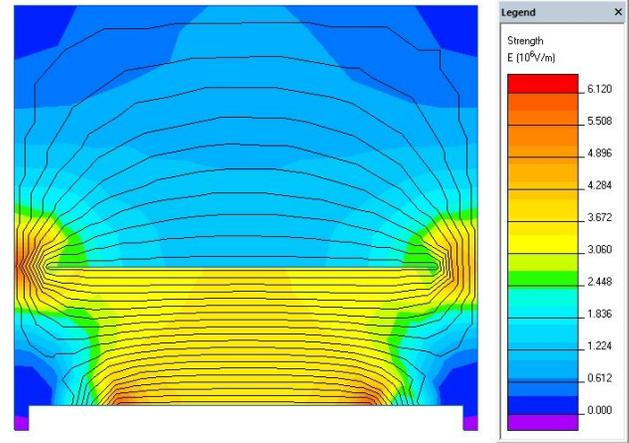
Figure 21d. Electric field strength model w/ mesh

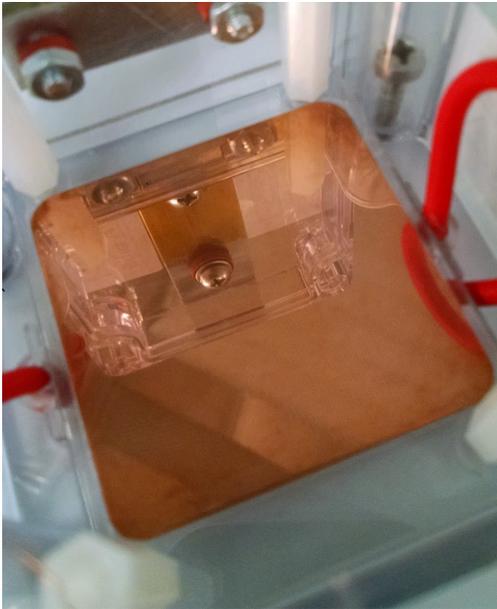
Figure 23a. Flown copper plate collector during analysis

The analysis of the sampled copper plate proved to be the biggest drawback and failure of the entire mission. When the sample was retrieved from the CSUN clean room, some high-powered optical microscopy time was planned for the following Friday at the College of The Canyons labs. Before the microscope appointment, the sample was taken out of the casting mold without problem. However, a deeply rooted fear that the acrylic resin would bond to the polycarbonate shell was confirmed. The sample on the copper plate was lodged in between two fused layers of acrylic and polycarbonate with no way of retrieving the sample with the method described before.

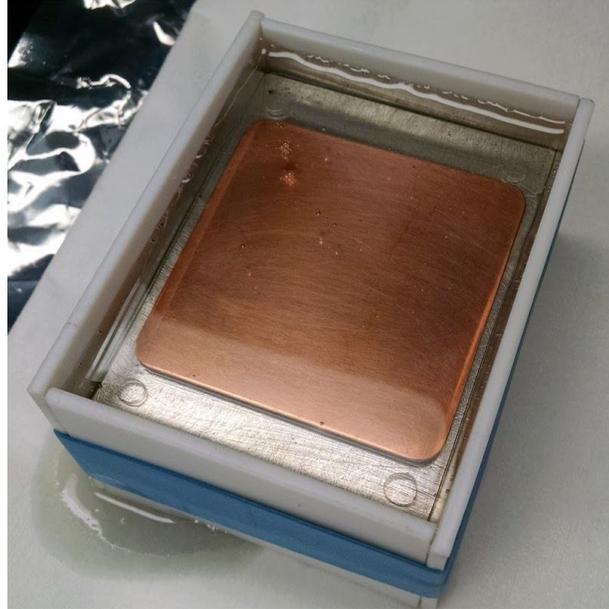
Figure 23b. Acrylic embedding of copper plate in custom mold

- Acrylic-embedded collection plate sample
 - New materials that do not bond to the acrylic sample such as PTFE or Nylon could be used to secure the copper plate instead of polycarbonate. Polycarbonate is chemically very similar to acrylic and therefore the two are very easy to bond together. This problem was hypothesized but no tests were run due to the schedule that needed to be followed in order to meet project deadlines. More time for testing of procedures would need to be set aside in the future to avoid mishaps such as this.
