High Altitude Student Platform (HASP) 2016

Electrostatic Comic Dust Collector (ECDC) Science Report

College of The Canyons
26455 Rockwell Canyon Rd
Santa Clarita, CA 91355

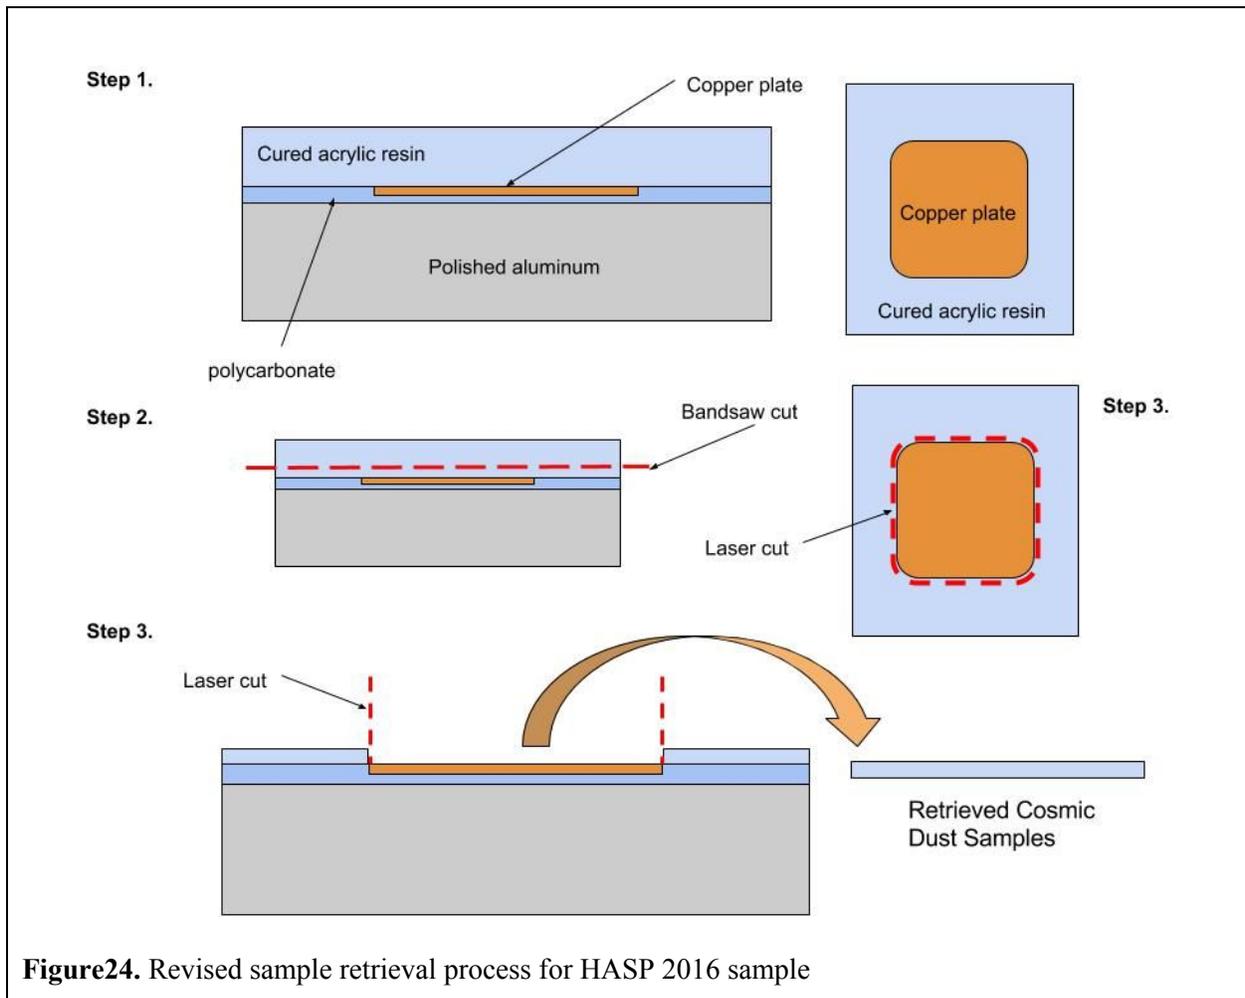
Figure 24. Revised sample retrieval process for HASP 2016 sample

A new method was developed by the team the next day that could be used to retrieve the needed sample from the polycarbonate. This method involved first using a bandsaw to cut away a slice of the top portion acrylic that does not contain particles. Then, once the acrylic is ~0.25 inches thick, a laser cutter would be used to cut the acrylic from the copper plate. This method would be risky since some vital particles could be burned away if they lie on the path of the laser, which by chance is the area with the greatest probability of finding particles. It was eventually decided that to avoid risking the sample, no analysis
