# SunbYte III HASP 2019 Science Report

## Abstract

**Date:** 31<sup>st</sup> January 2020

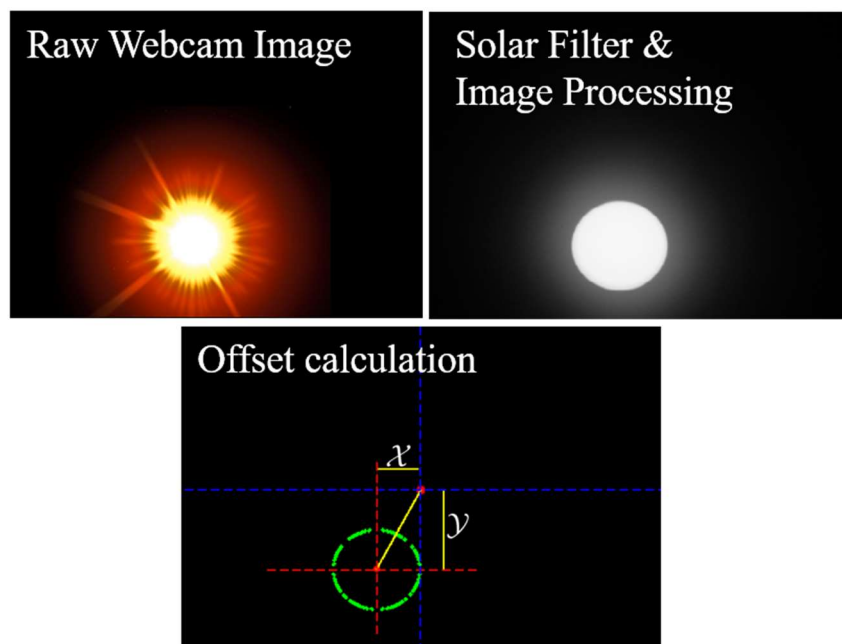
Figure 2.2.1.a: Tracking Image Processing Algorithm

The Attitude Determination and Control System will use image processing to localize and track the position of the Sun. Images are taken at 30 FPS with a webcam interfaced with a Raspberry Pi (RPi) microprocessor. Tracking of the Sun is carried out in two steps. Firstly, the pitch and yaw motors sweep the camera across the sky. Meanwhile, an image processing algorithm running on the RPi scans the incoming webcam video feed, isolating the largest brightest object, sweeping continues until an object is located.

Once the Sun is detected the tracking algorithm takes over, centring the telescope on the Sun by continuously adjusting pitch and yaw motor positions. The RPi calculates the offset in orientation of the Sun from the centre of the image and translates the difference into corrections for the yaw and pitch angles (shown in figure 1.3.2.a), sending them to the Teensy 3.6 microcontroller (MCU) to adjust the motor positions.

The tracking algorithm used a proportional controller in each of the vertical (pitch) and horizontal (yaw) directions to convert the offset in pixels to stepper motor steps. This algorithm would continually update multiple times every second to ensure the tracking was smooth.

During development, minor adjustments were made to this algorithm as the system changed, for example an estimation of the Sun's initial position based on magnetometer and GPS data, was originally going to be used as a start location for the search of the Sun's position. Although after testing the magnetic interference from the stepper motors meant the inertial measurement unit (IMU) with the magnetometer was unusable and was thus removed.

A webcam to telescope offset was also later added due to the physical precision limitations of directly the webcam and telescope in the same direction. A centre offset was added to correct for this, which needed to be calibrated after any critical adjustments to the payload.

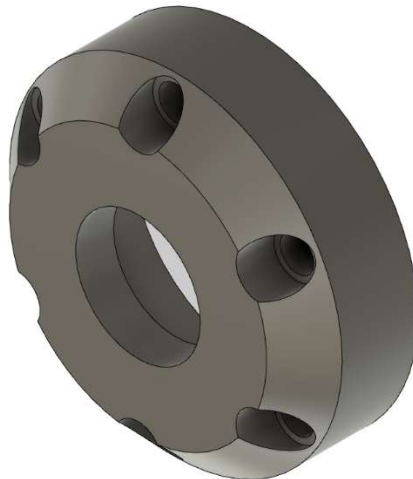
Figure 2.6.2.1.4.a Bearing Case

The bearing case was used the pitch shaft assembly to prevent the pitch shaft from moving laterally. This was designed such that the bearing is secured by press fitting it into the case, the press fit nature meant that no adhesive would be required to secure the bearing in place.

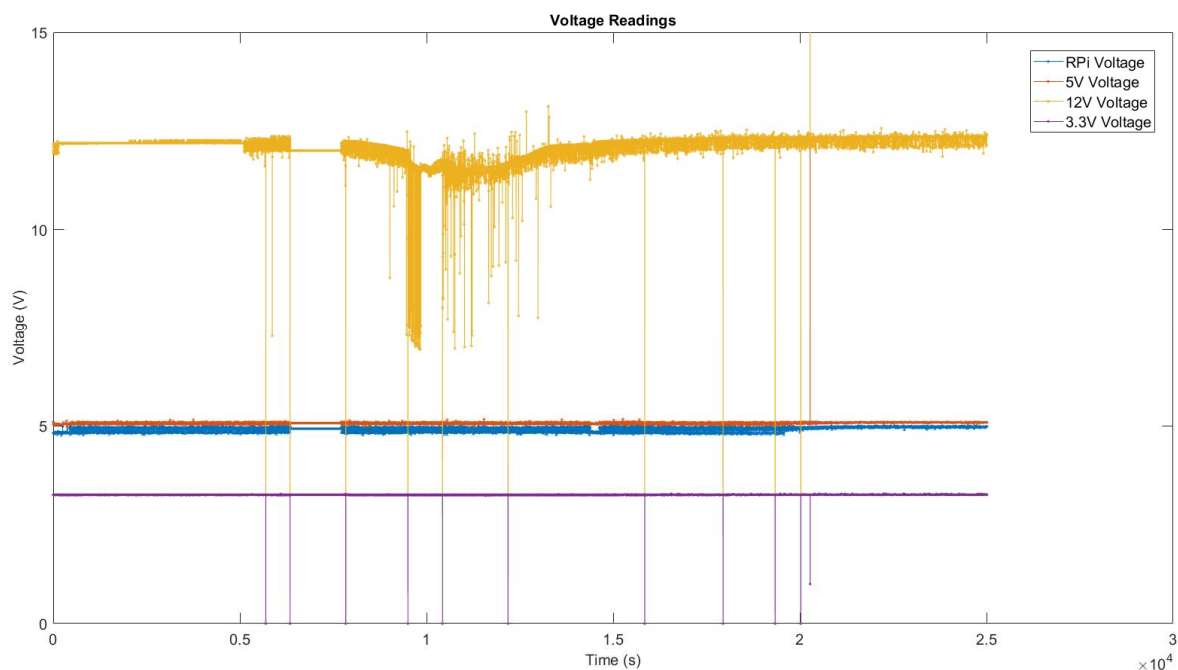
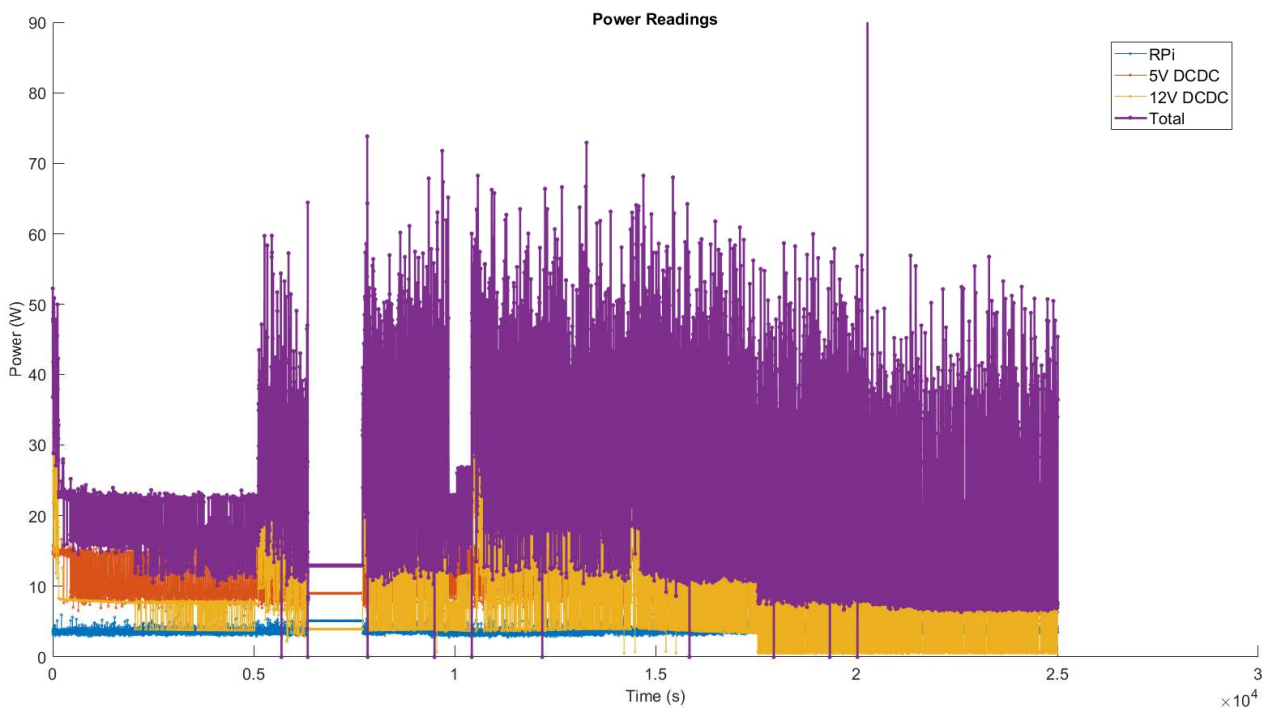
Figures 4.3.1.a-c show current, voltage and power data from the 4 current sensors located on the 12V, 5V and 3.3V lines, alongside the RPi power input. The voltage data is as expected for all except the 12V line, which dips in the early-mid-flight, while the most 12V components were active.

The current data is highly variable over large timescales due to high current draw components frequently turning on and off in time scale ranges of seconds to tens of seconds. These components are the science filter (5V), heaters (12V) and motors (12V). The plot indicates some brief moments where the current rises to well above the rest of the data and the safe limits, though these were found to be inaccurate measurements. The total current never truly exceeded 2.5A at 30V and hovered between 1 and 2 Amps. This resulted in a mean power draw of 32W, which was safely below the limits for a large payload.

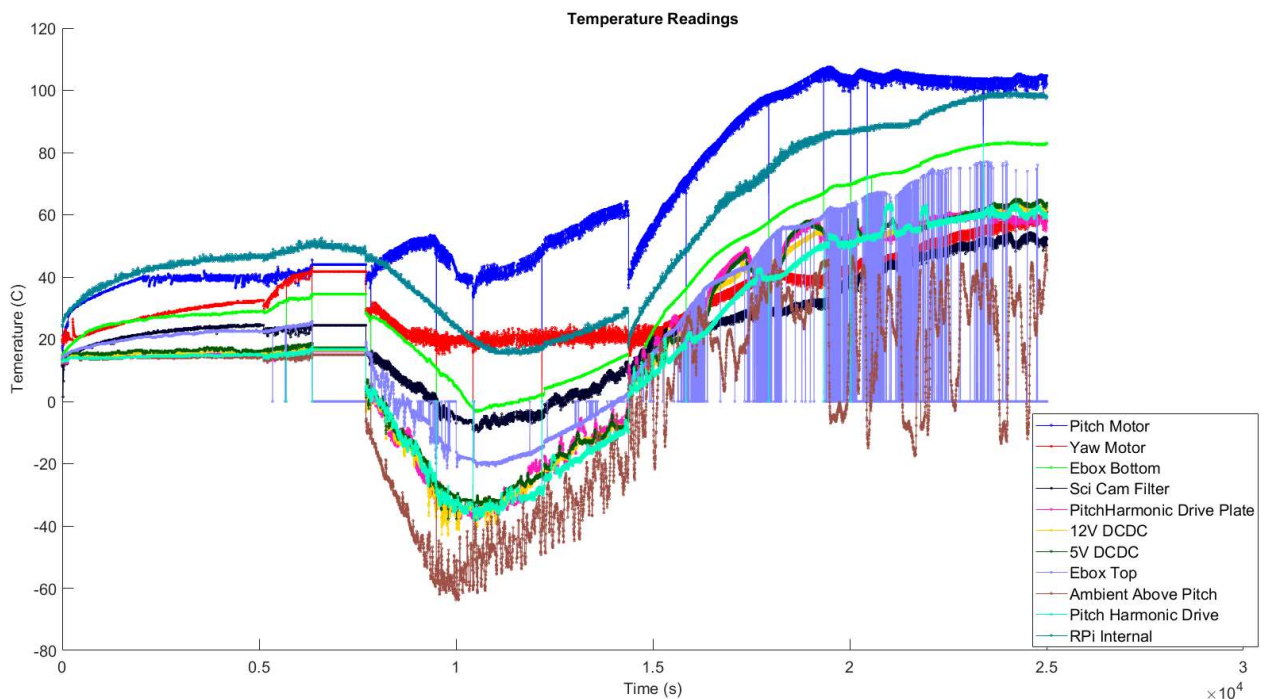
Figure 4.3.1.d Temperature Readings

The temperature data shows a large range of temperatures were present across the payload, spreading out from the initial temperatures at launch. Despite issues in the measurement records, particularly in the 'Ebox Top' sensor, a profile of temperature from each sensor is present.

The optics equipment was well insulated using the MLI and remained within its thermal operating range and below 50 degrees for the duration of the flight.

In summary, the large number of thermocouples provided significant insight into how the payload behaved during the flight. This can influence future design decisions to improve thermal performance of the payload, particularly given the temperatures appear to reach a steady state towards the end of the flight.

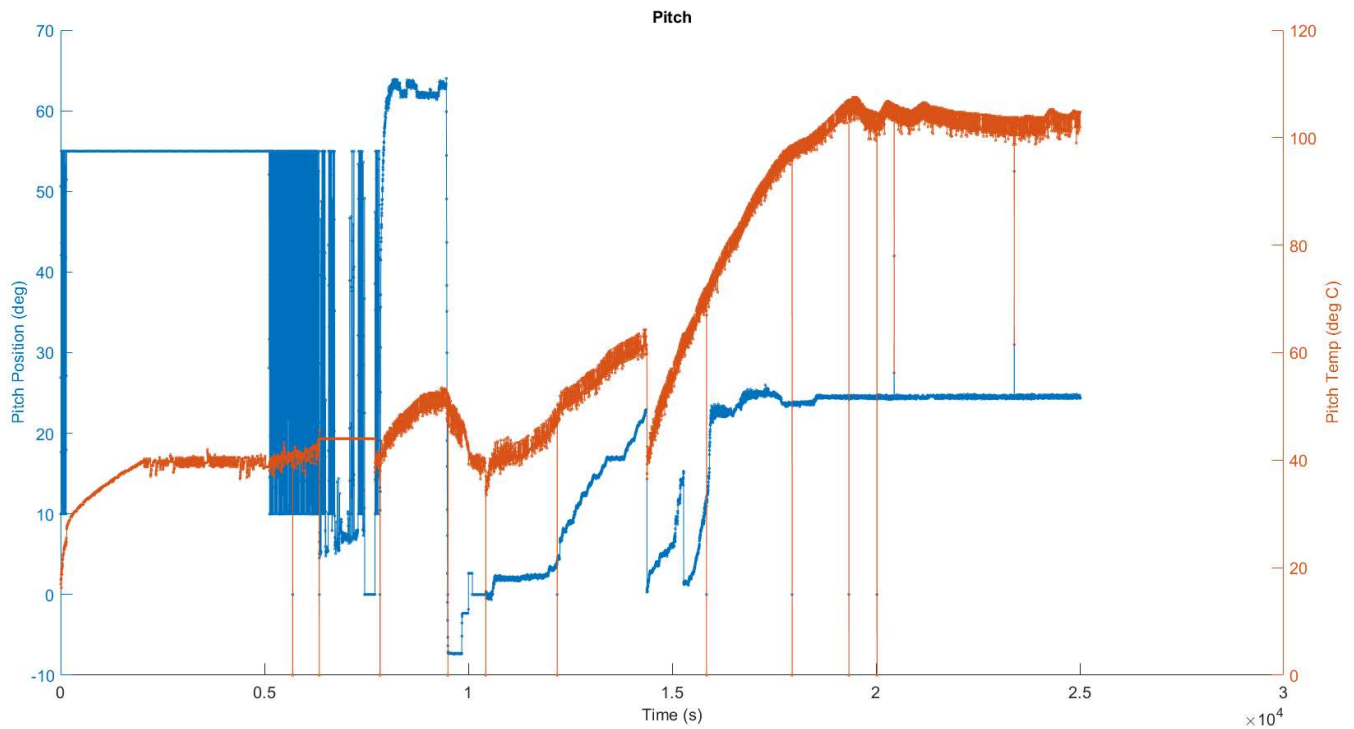
The following three plots 4.3.1.f-h show the pitch and yaw motor positions combined with their temperature readings, followed by the settings for motor speed and acceleration. At the beginning of the flight the system was operating successfully. Once it became sluggish, it was manually turned off for the remainder of the ascent, due to the system cooling and becoming too difficult for the motors to move. This was due to reaching the torque limit for the motors used, alongside colder components becoming increasingly difficult to turn. Shortly after reaching ascent, the movement resumed as planned, sweeping successfully multiple times, then tracking the Sun. However, this did not last long before problems began occurring.

period of time. Over this time the Sun shone on the more exposed pitch motor for a long duration heating the motor up, through the insulation, to well over 110 degrees.

Initially this was thought to be a problem with the heating system, though upon reaching over 70 degrees we become doubtful of this, realising the cause of the temperature increase was due to the Sun, despite expectations that the gondola's constant rotation would not allow this to happen. We attempted to correct the issue by repositioning the still functional yaw motor, to shade the pitch motor. Due to the excess heat and lack of convection the motor did not cool enough to resume operation, remaining stuck, pointing well above the Sun's location.

The pitch motor overheated to 110 degrees Celsius soon after entering the "hot zone". The motor was not operational for the remainder of the flight. Without the pitch motor, no tracking could be performed. The Rpi core temperature reached around 90 degrees Celsius during flight. Observations from the thermal chamber showed that the processor throttles automatically to avoid overheating completely, because of this, the processor did not shut down during the flight. Post-flight analysis showed the thermal paste connection from the Rpi heatsink to the heat pipe had failed, essentially isolating the Rpi from any form of conduction away from its heatsink. This meant the component stayed cooler for longer, but ultimately became too hot and began throttling its clock speed.

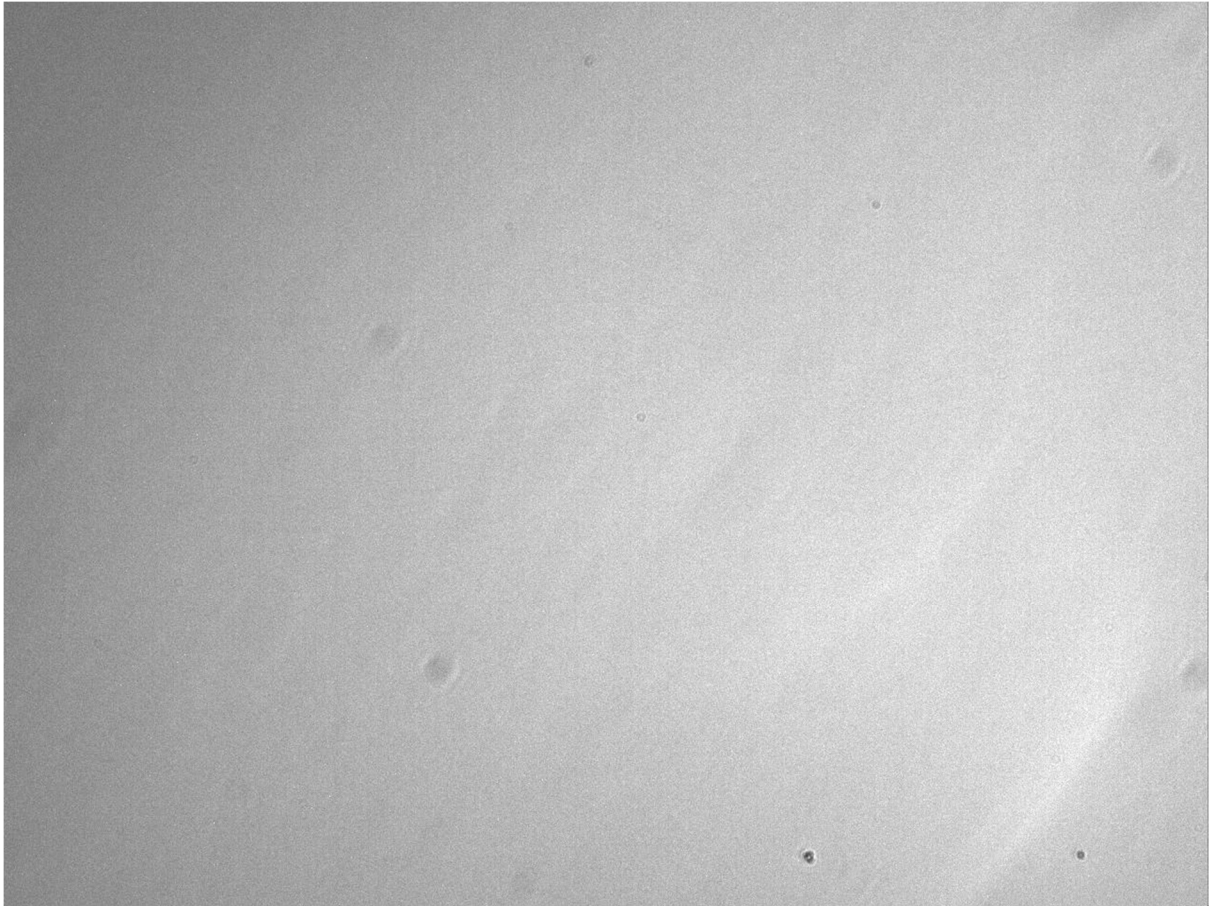
Figure 4.3.3.a Only Non-Black Telescope Image at 1567688588.27 UNIX

Unfortunately, all but one of the science camera images were completely black, shown in figure 4.3.3.a. The image is clearly much brighter than the other recorded images, with a gradient across it. Also, imperfections are present in the image, which are likely to be specs of dust, which were otherwise not visible in the darkness and other particles and marks on the lens.

Correlating the timings of the image from the science camera with the images from the tracking camera, the Sun lines up with the webcam, factoring in the calibrated offset to account for the positioning of the two cameras. The webcam image (figure 4.3.3.b) was taken at 1567688588.25 UNIX time, while the science camera image was taken at 1567688588.27 (UNIX time), only 0.02 milliseconds apart. The science camera image may not be well focused or clear, but for the short period the tracking system was operational and not sweeping to find the Sun, this single image demonstrates a successful implementation of the tracking system and the SunbYte project as a proof of concept.

The timing of the image coincides with 6,347 seconds in the telemetry data, which match the section where tracking took over from sweeping, before an issue occurred with the motors.

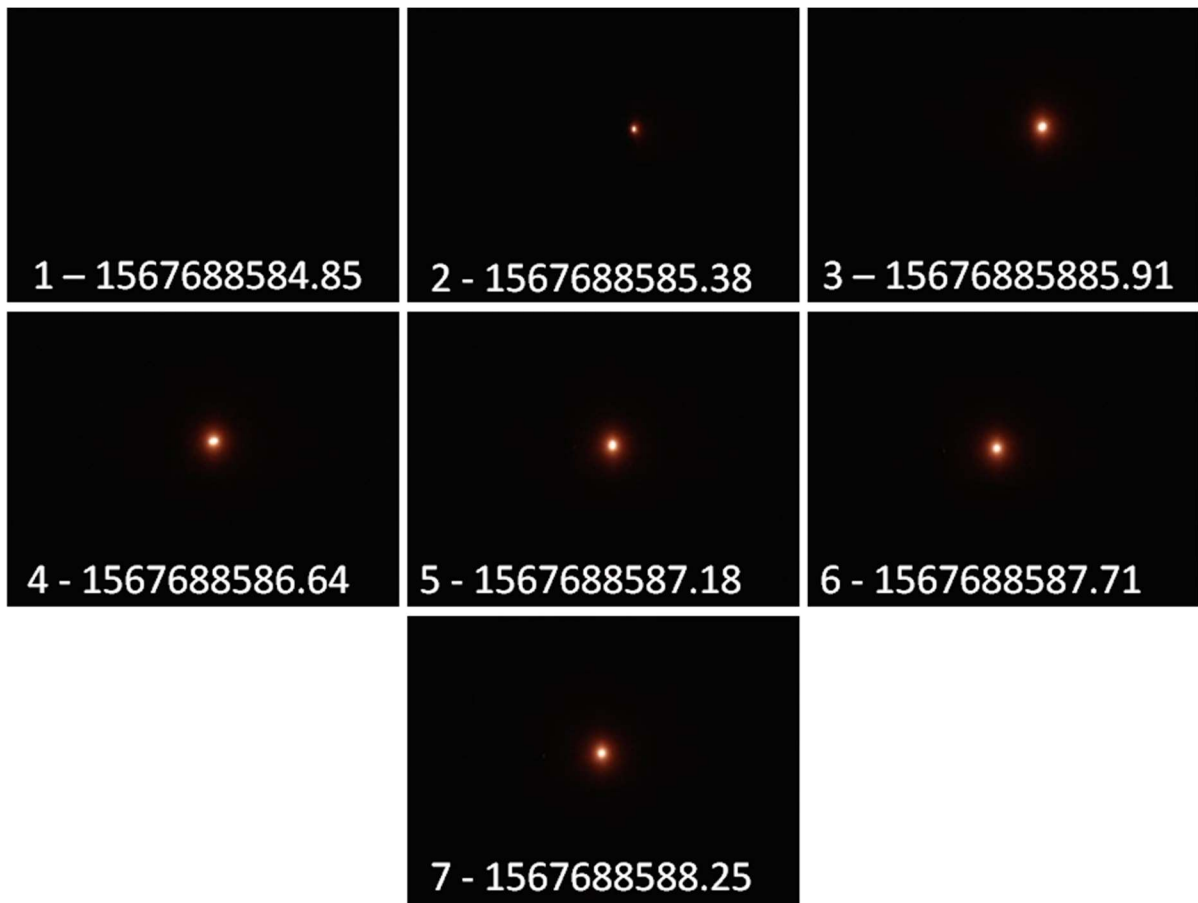
Figure 4.3.3.c Tracking Camera Sequence

The sequence of tracking camera images leading up to the capture of the non-black science camera image is shown in figure 4.3.3.c, demonstrating the capability of the tracking system to home in on the Sun by making small adjustments.
