HIGH ALTITUDE STUDENT PLATFORM

MAGNETIC INVESTIGATION OF LUNA (MIL)

PAYLOAD FLIGHT SUMMARY

VIRGINIA POLYTECHNIC INSTITUTE AND STATE UNIVERSITY

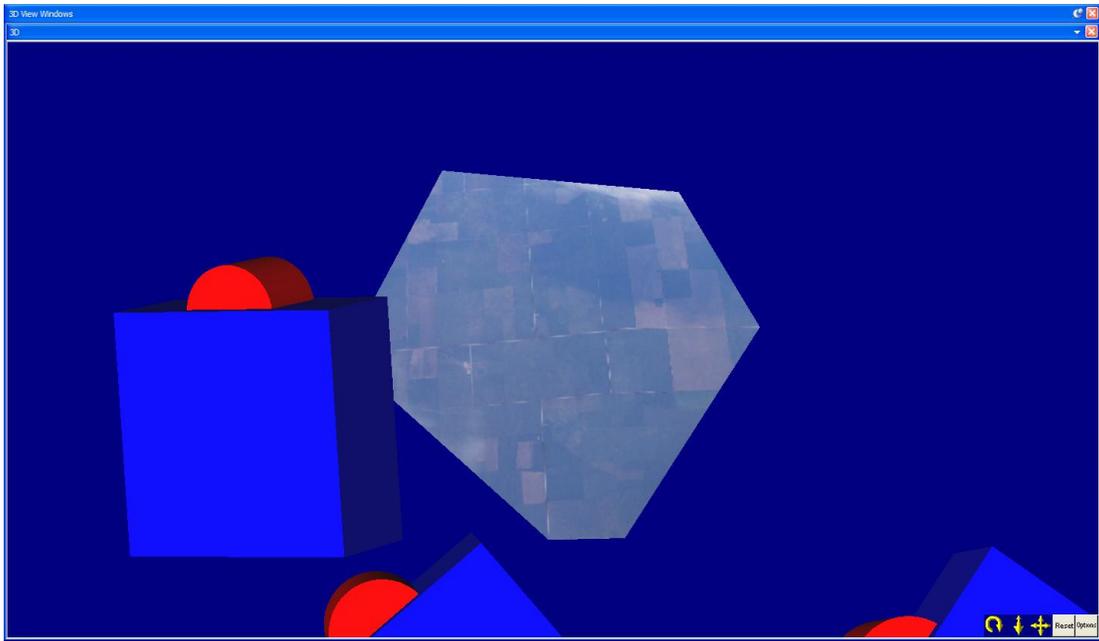
Figure 5 2D map of the area studied, rendered by the photogrammetry software.

There is an arrow drawn to the corn field in each figure for clarity. The x's represent different points common to each set of photographs that the software used to resolve the camera positions and height. A 2D map of the earth's surface, the cornfield studied, was successfully generated in Photomodeler (Figure 5). Defining a reference length by using the position of the
